Peters Canyon and Vista Panorama Reservoir Condition Assessment

Subject: **GEOTECHNICAL AND SEISMIC HAZARD ASSESSMENT REPORT**
Existing 6-Million Gallon Reservoir
East Orange County Water District
Handy Creek Road
Orange, California

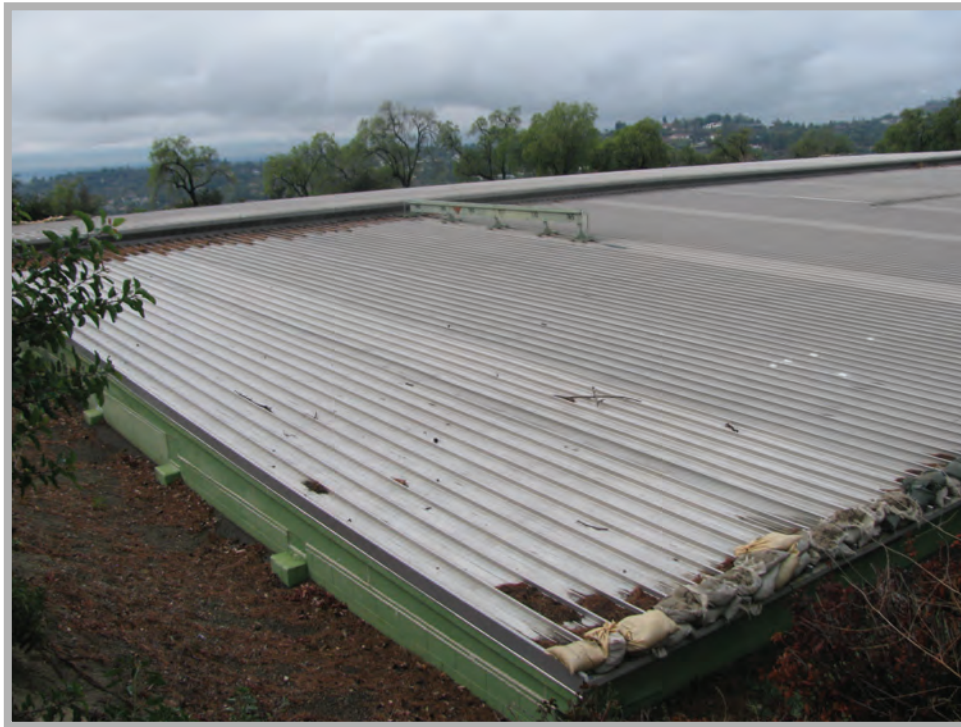
Photo B.1
Peters Canyon Reservoir Roof Looking South West

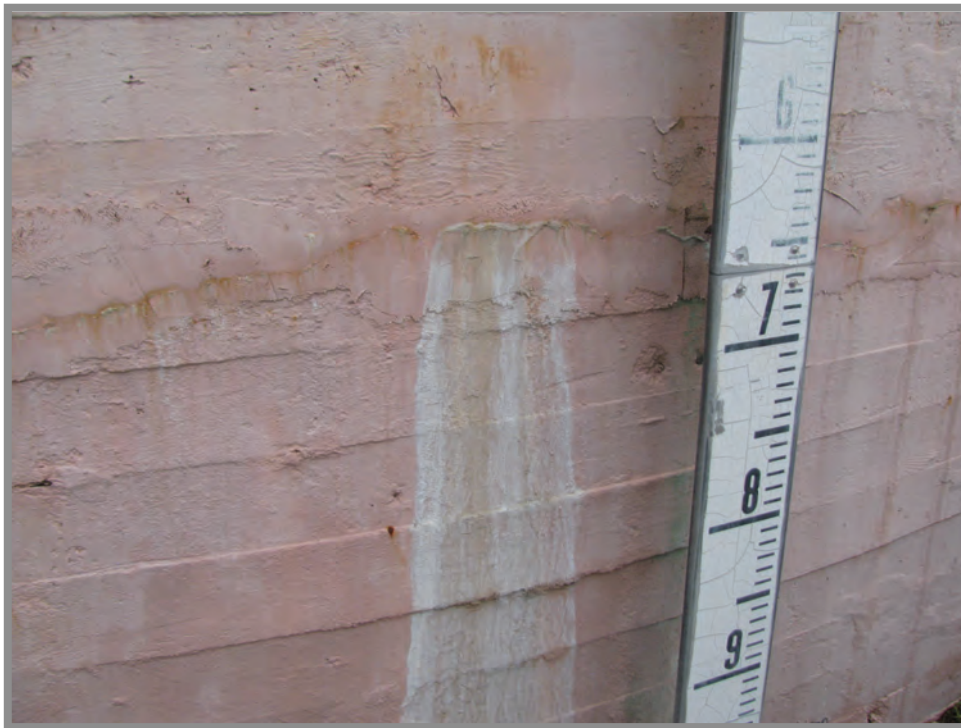
Photo B.18
Vista Panorama Reservoir Wall Elevation with Evidence of Water Leak

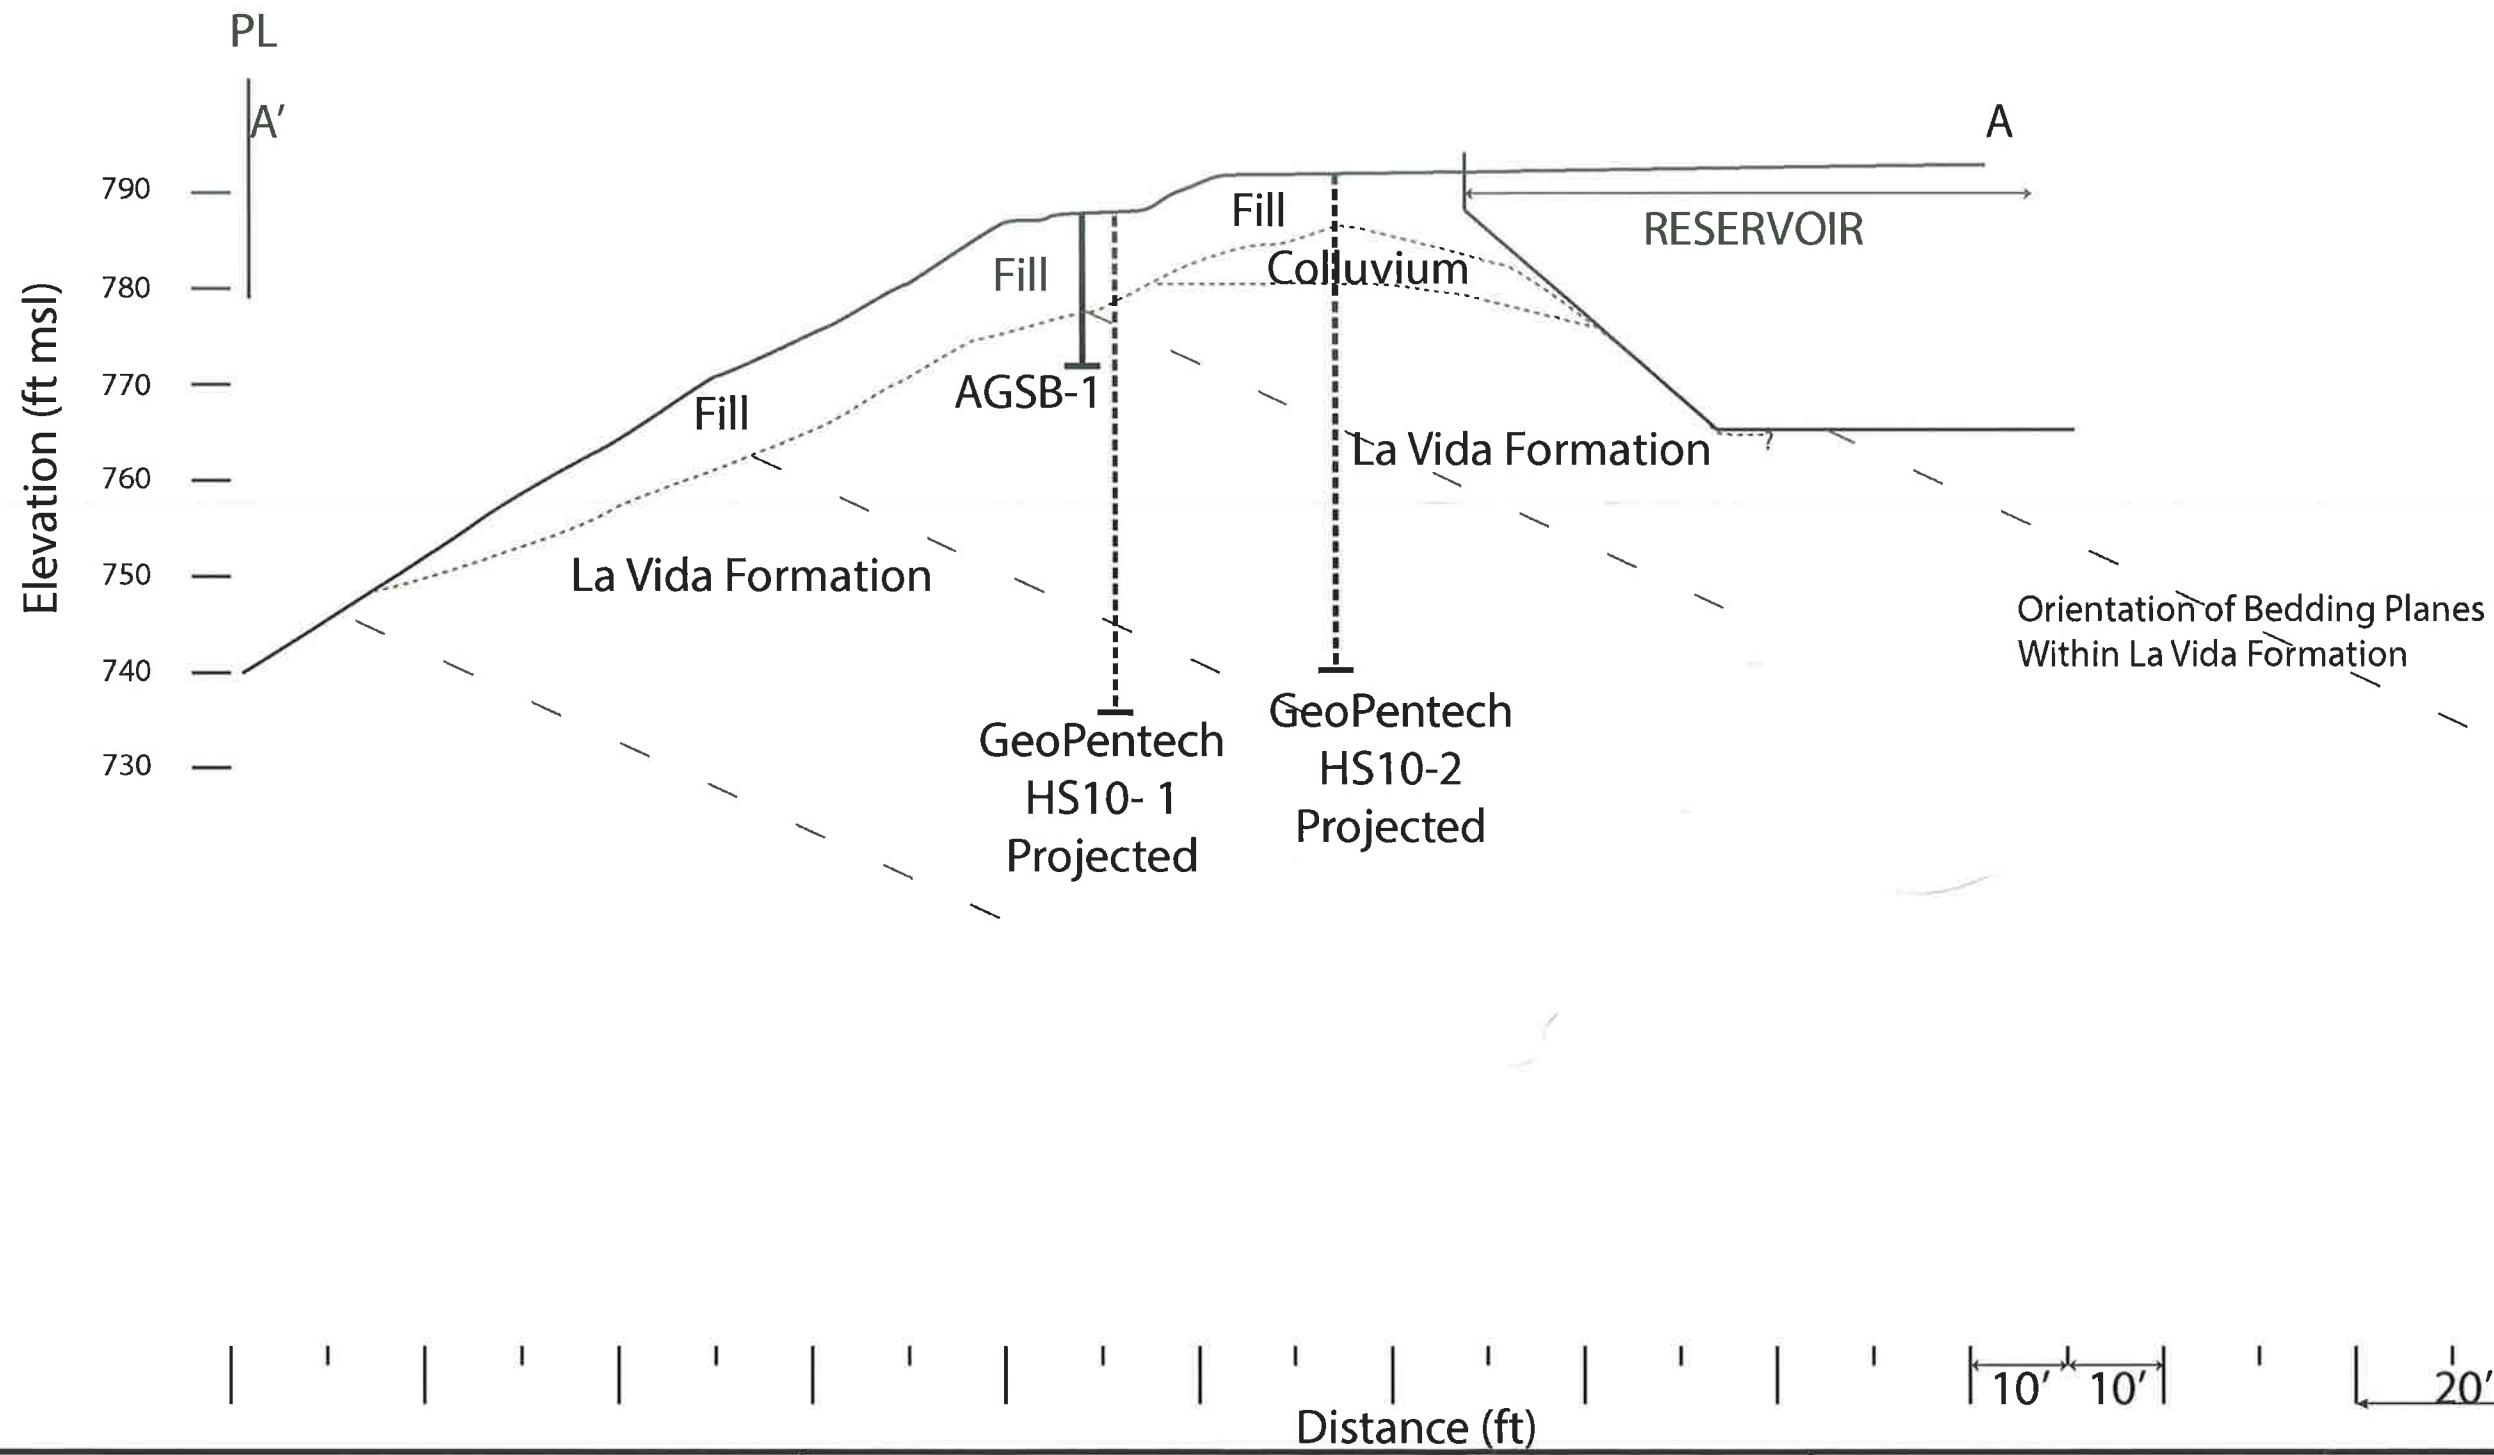
Plate 3

Five different geologic cross-sections (Sections A-A' thru E-E') were developed to depict the underlying fill soil and bedrock conditions at the locations depicted on Plate 3. These cross-sections (see Plates 4 thru 6) were used to assist in selection of critical sections for the slope stability analyses (presented later in this report).

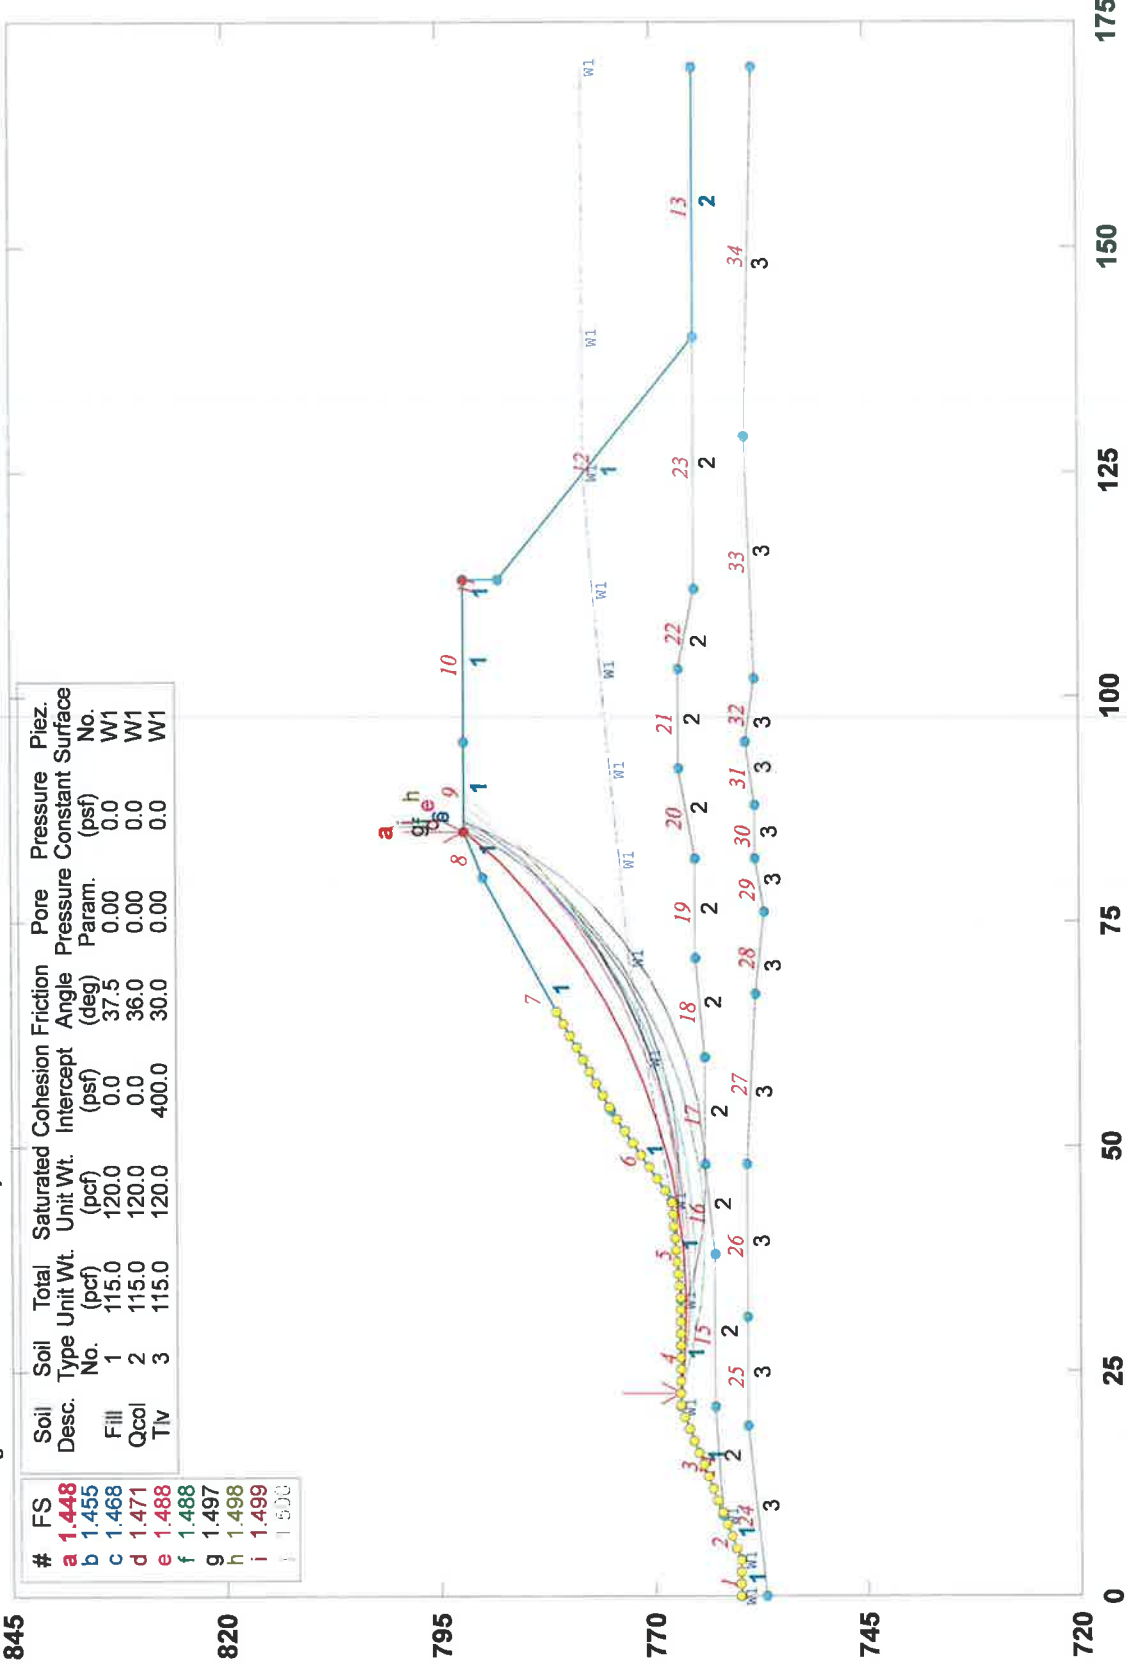
Section D-D' and Section E-E' (upper) have reduced factor-of-safety of 1.448 and 1.413, respectively, under moderate leak, partially saturated conditions (groundwater rising half-way in the fill soils). However, Section E-E' (lower) has a significantly reduced factor-of-safety of 0.667 under these same partially saturated conditions.

#	FS
a	1.448
b	1.455
c	1.468
d	1.471
e	1.488
f	1.488
g	1.497
h	1.498
i	1.499
j	1.500

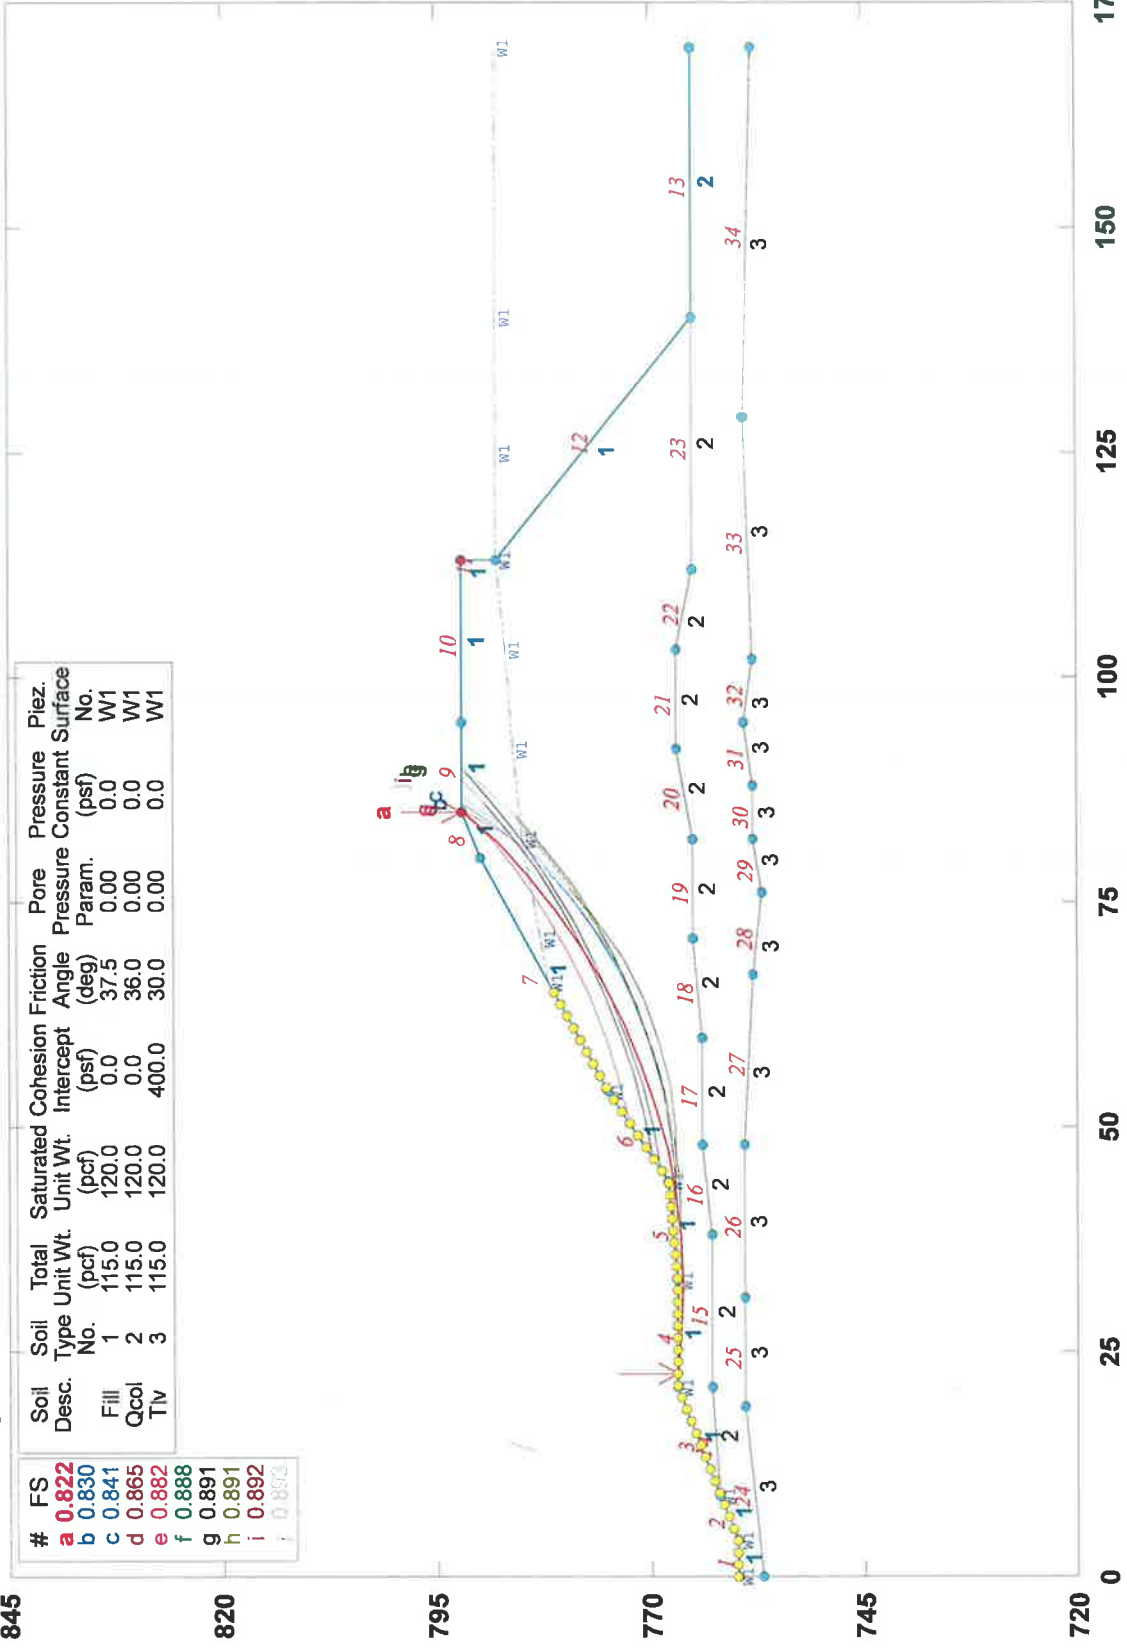
Further reductions in the factor-of-safety under static, fully saturated conditions (groundwater rising in the fill soils to near ground surface) occur in all cross-sections with Section D-D' reducing to 0.822, Section E-E' (upper) reducing to 0.941, and Section E-E' (lower) reducing to 0.667.

#	FS
a	0.822
b	0.830
c	0.841
d	0.865
e	0.882
f	0.888
g	0.891
h	0.891
i	0.892
j	0.893

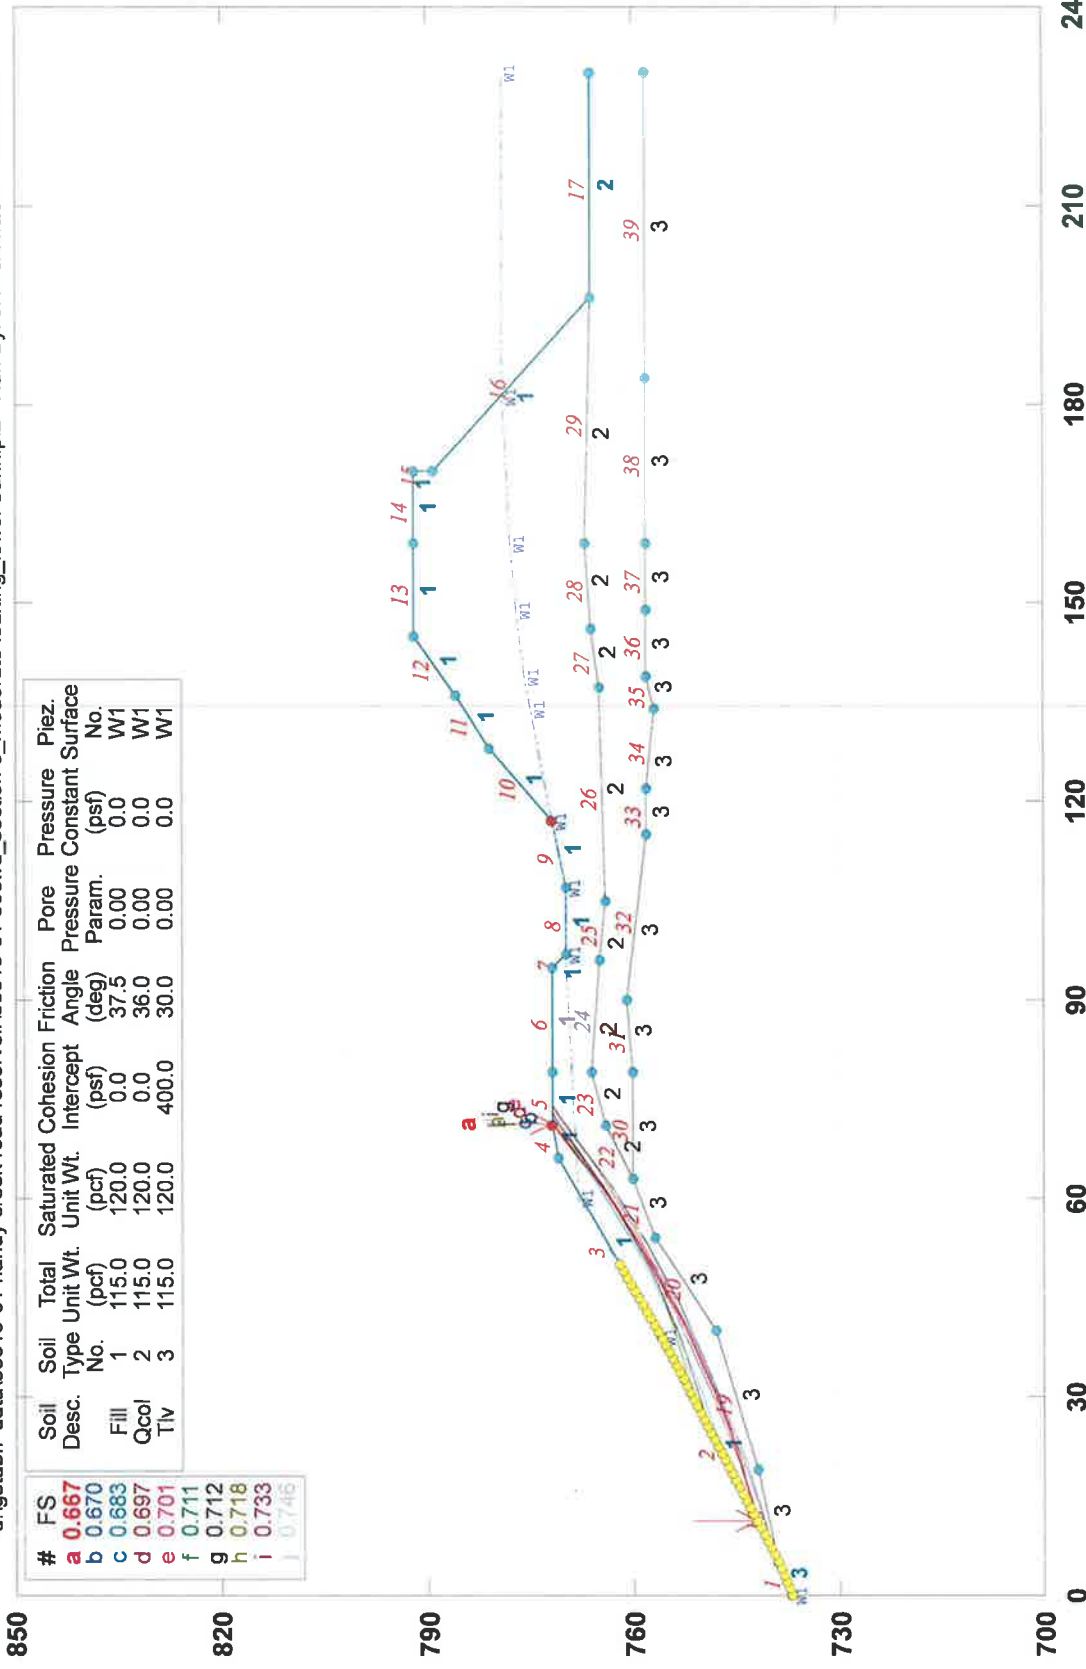
These analyses identified that the lower portion of hillside slope for Section E-E (located from the entrance road northward to the toe of the fill slope) has a factor-of-safety below 1.5 under static conditions with moderate to severe leak conditions.

GSTABL7 v.2 FSmin=0.667
Safety Factors Are Calculated By GLE (Spencer's) Method (0-1)
