# Peters Canyon 6MG Reservoir

Instrumentation Monitoring May 2025

Subject: Instrumentation Monitoring Report  
Peters Canyon 6 MG Reservoir  
Orange County, CA

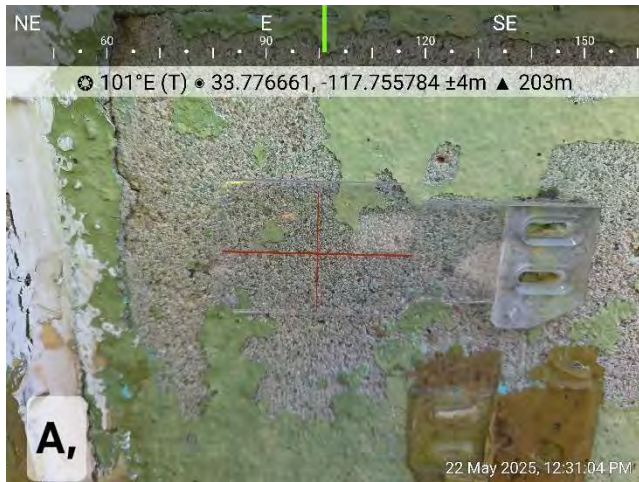
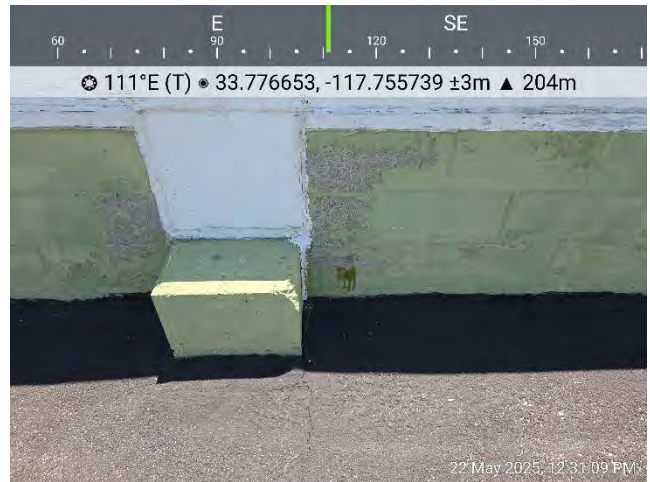
- Crack monitors in Table 2 were replaced with new devices in the same location, and a new baseline reading was taken, as shown in Table 3 above.
- Crack monitor A' and F' were found detach at the time of the site visit. Adhesive for F' appeared to have worn out. A portion for crack monitor A' was missing. All wall crack monitors will be reinstalled and reinforced with significant adhesive.

**Close up view:** Portion of corner tale Crack Monitor A" missing

**Far view:** Portion of corner tale Crack Monitor A" missing

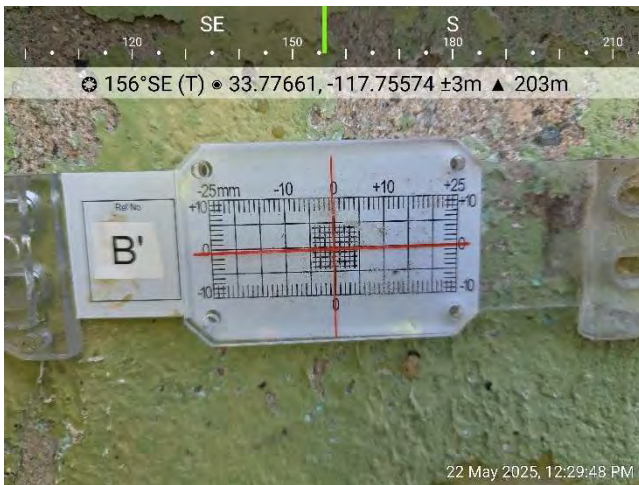
**Close up view:** Corner tale crack monitor B"

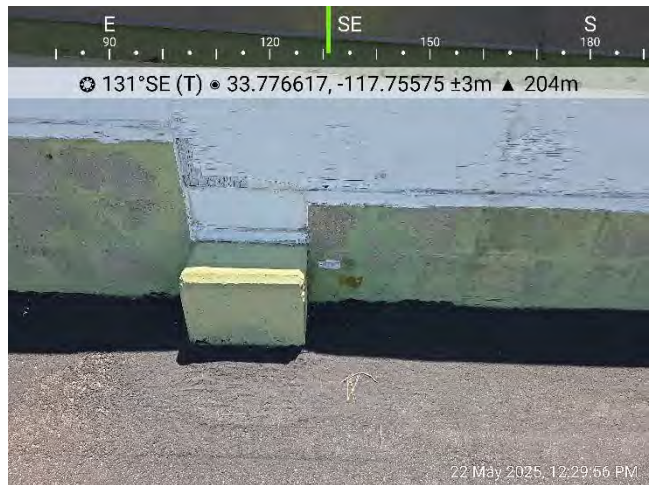
**Far view:** Corner tale crack monitor B" relative to pilaster

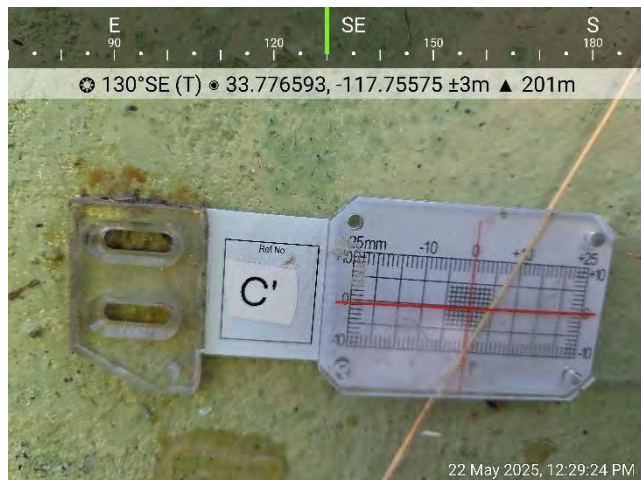
**Close up view:** Corner tale crack monitor C"

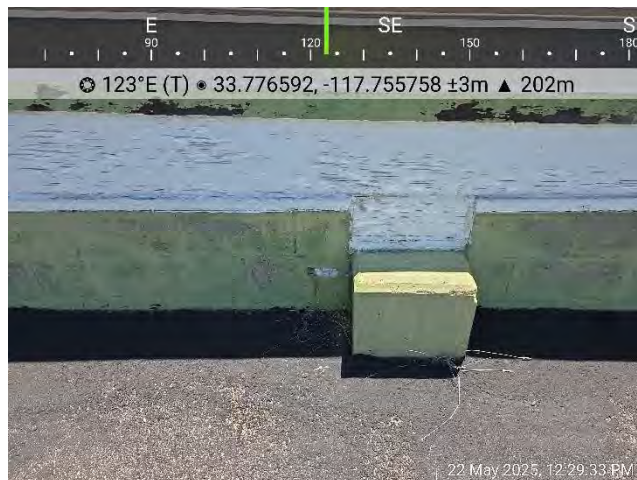
**Far view:** Corner tale crack monitor C" relative to pilaster

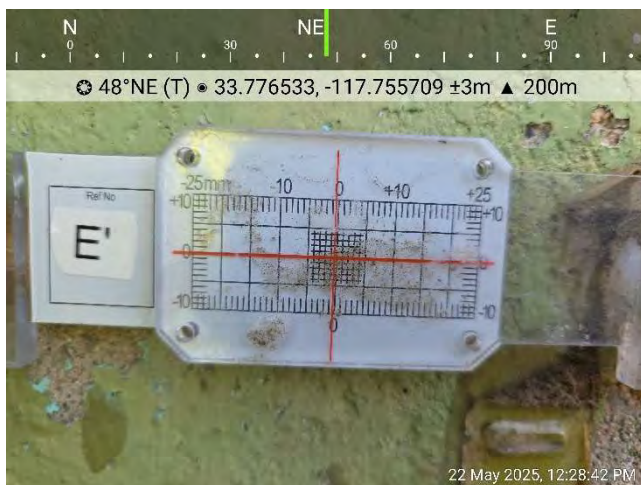
**Close up view:** Corner tale crack monitor E"

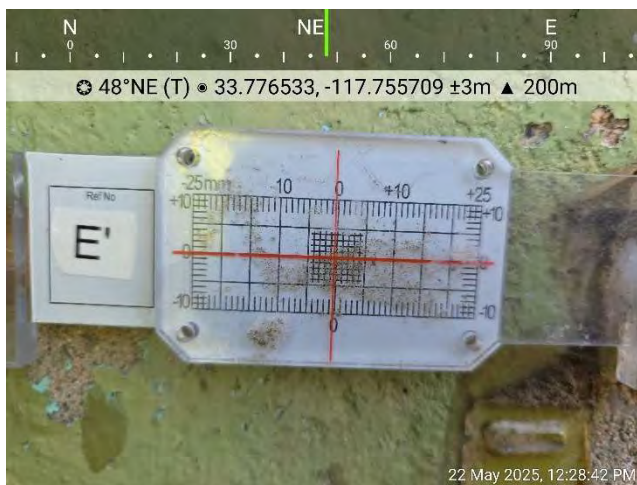
**Far view:** Corner tale crack monitor E" relative to pilaster

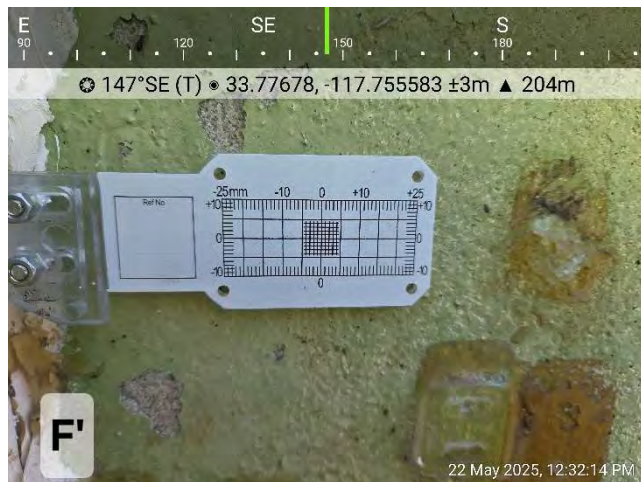
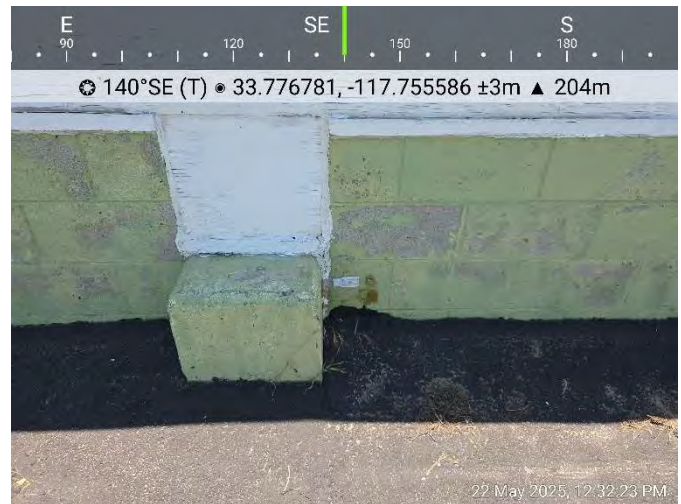
**Close up view:** Corner tale crack monitor F" with one side detached

**Far view:** view of F" relative to pilaster with one piece on top of pilaster

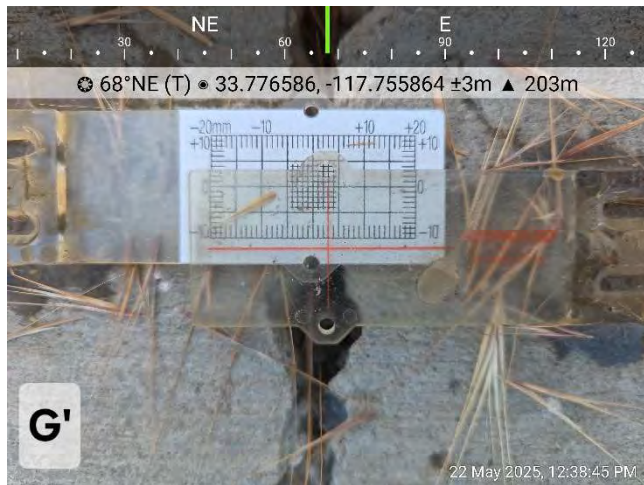
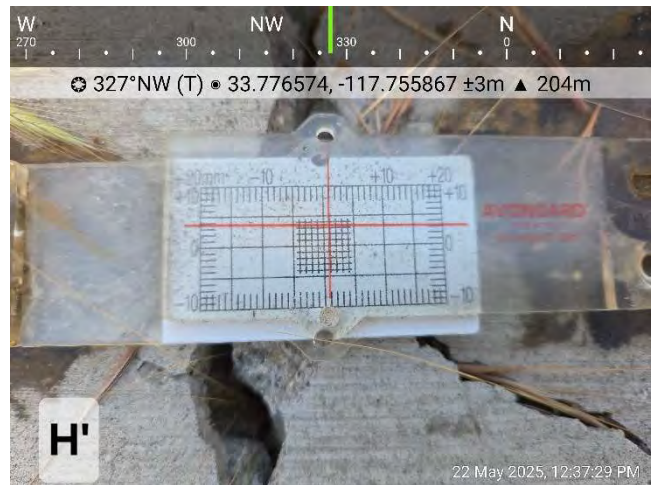
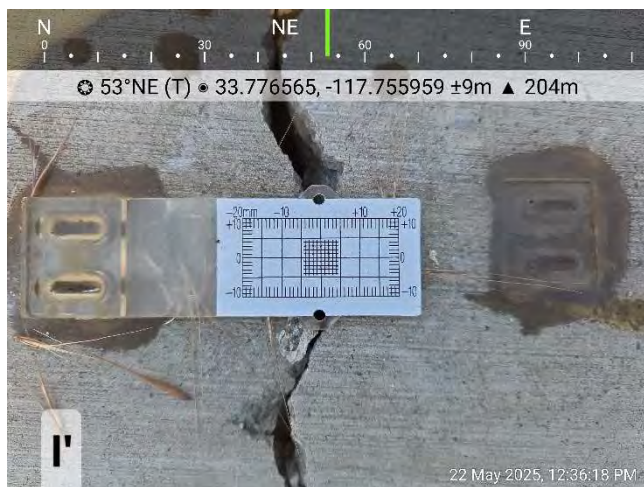
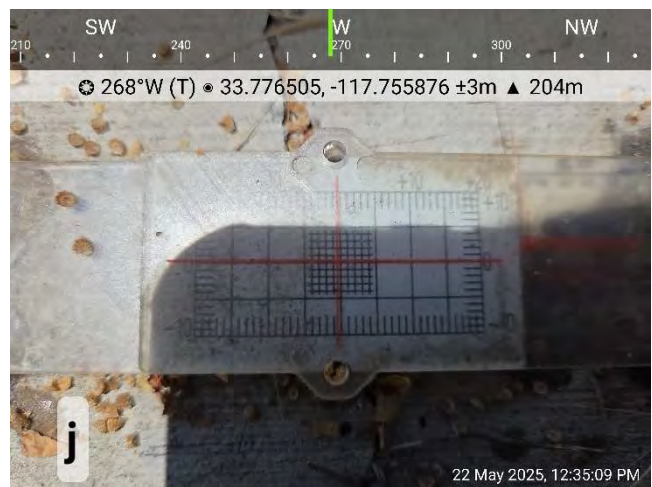
\* Crack Monitor G': based on our field observation, the greater deviation between 12/20/2023 and 12/23/2024 readings are due to the movement of the curb pieces (separated pieces from day first). Therefore, there is no concern of any exceeded crack or slope movement. Crack monitor I' needs replacement.

\*\* Crack Monitor G': based on our field observation, the minor movement between 12/23/2024 and 5/22/2025 readings are possibly due to the movement of the curb pieces. Inclinator data does not show significant changes, therefore, there is no concern of any exceeded crack or slope movement. Crack monitor I' needs replacement.

**Close up view:** observation of existing curb crack monitor

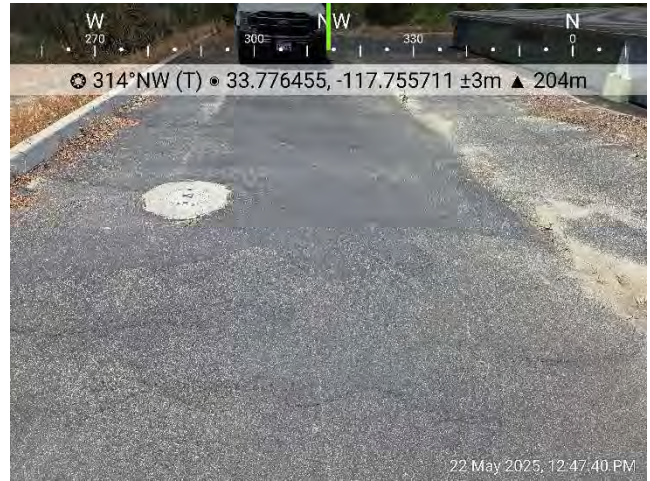
**view:** South end of site. Low severity longitudinal and transverse cracking

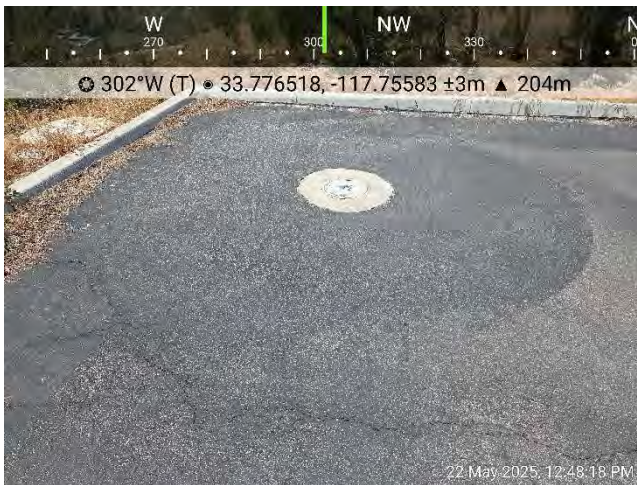
**Close up view:** observed low severity cracking near inclinometer boring A-21-1

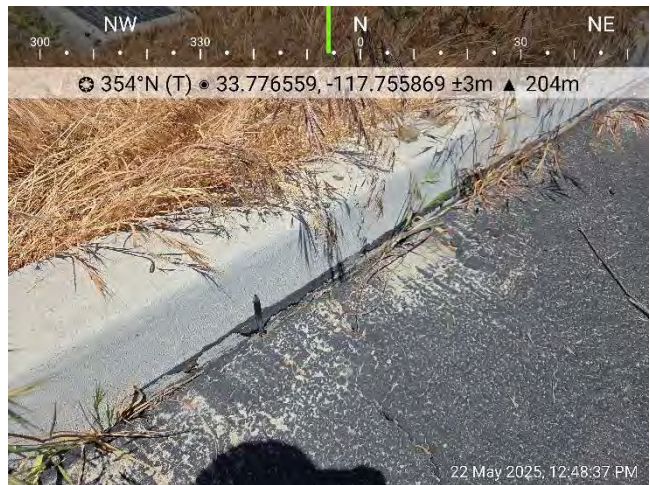
**View:** low severity edge cracking along Southwest Curb

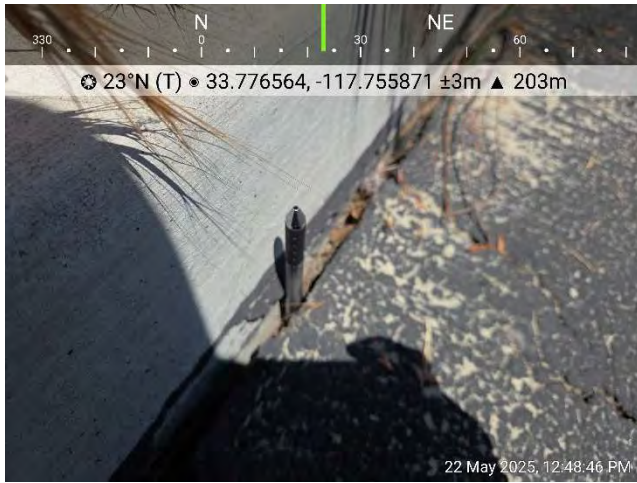
**Close up view:** minor edge cracking observed

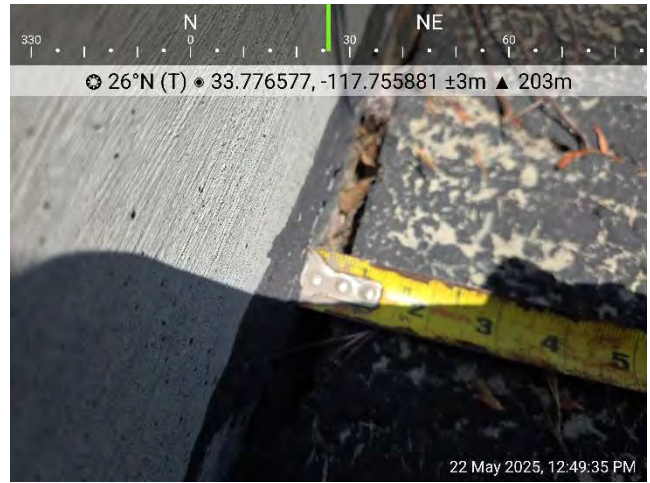
**Close up view:** minor edge cracking measured.  
Less than 1"

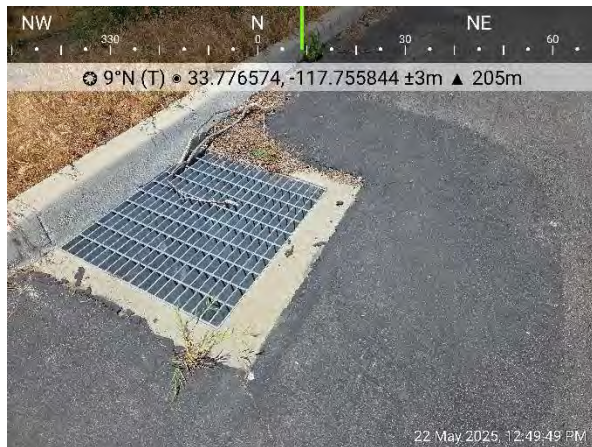
**view:** minor cracking observed around drainage system

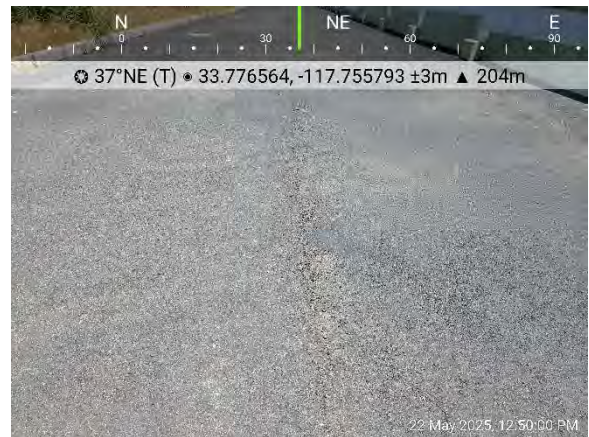
**view:** longitudinal cracking and raveling observed throughout asphalt surface.

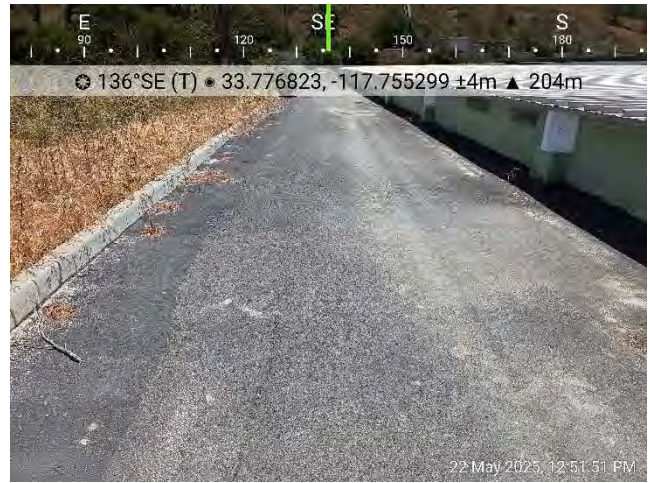
**view:** Asphalt surface along the North end of the site. Low severity cracking observed

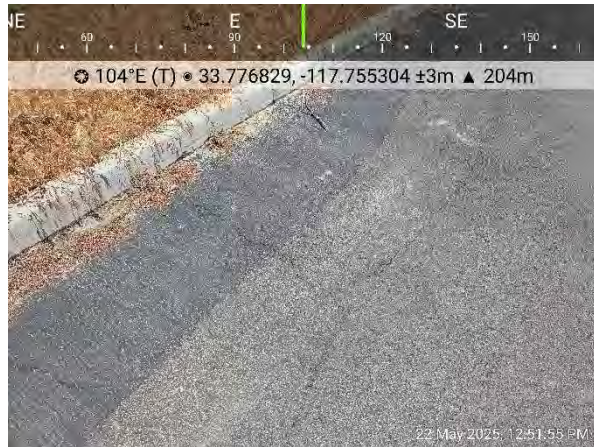
**view:** Asphalt surface along the North end of the site. Low severity cracking observed

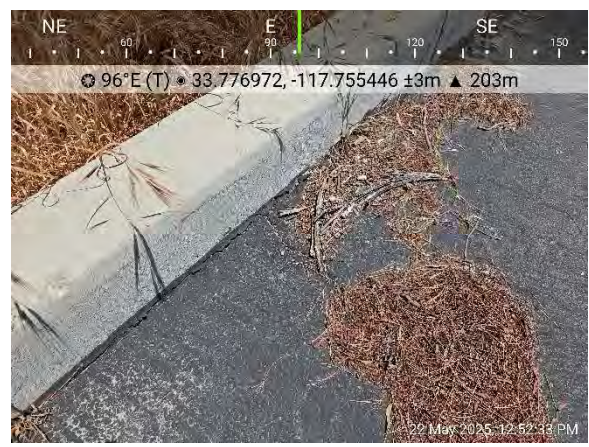
**view:** low severity cracks near north end concrete curb

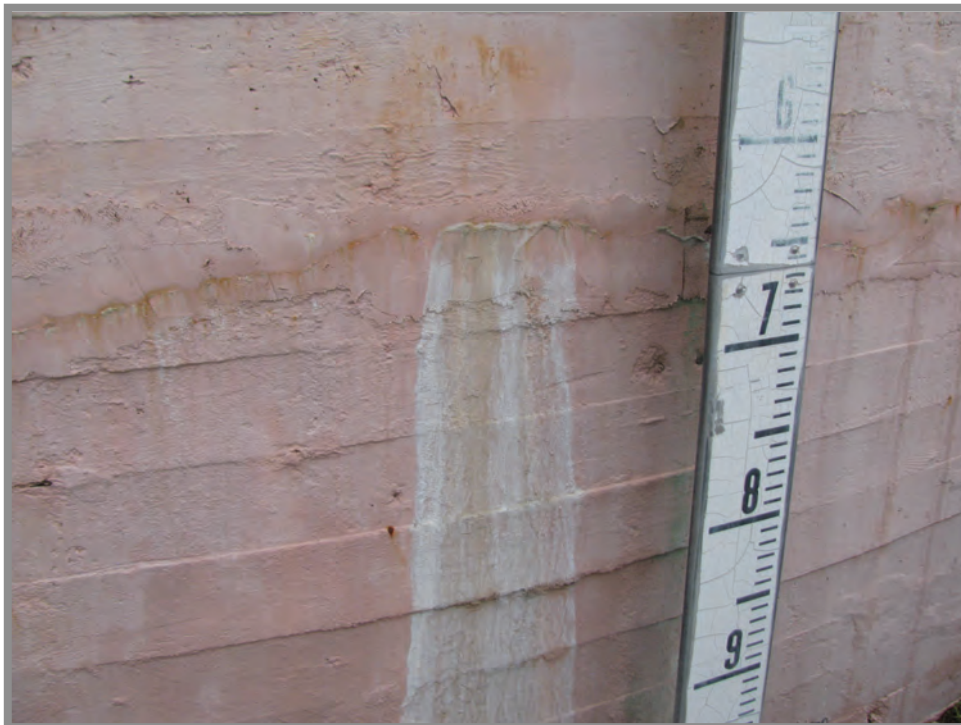
Photo B.18  
Vista Panorama Reservoir Wall Elevation with Evidence of Water Leak

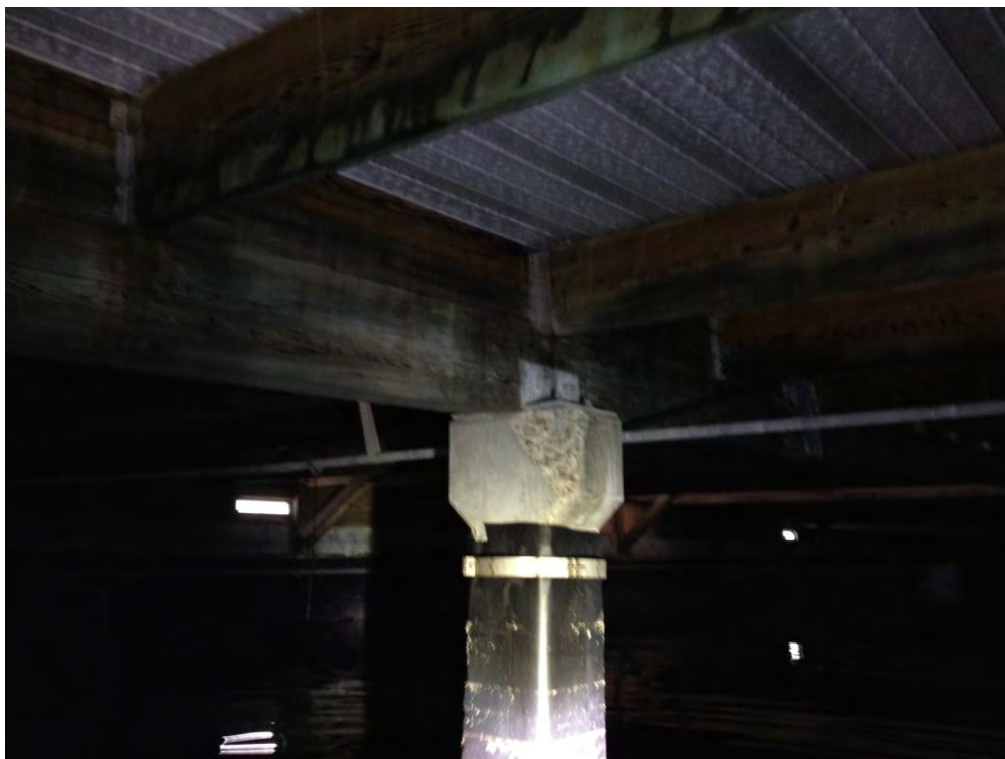
CONCRETE COLUMN WITH BROKEN CORNER

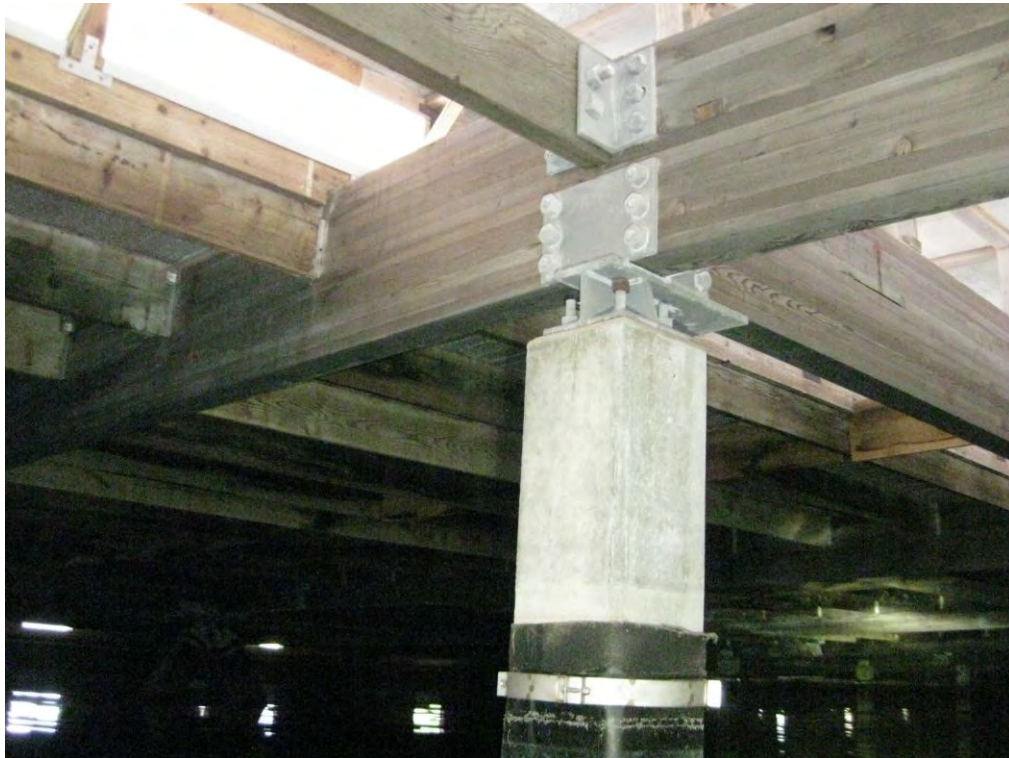
COLUMN WITH LOOSE NUT ( NON-GALVANIZED)

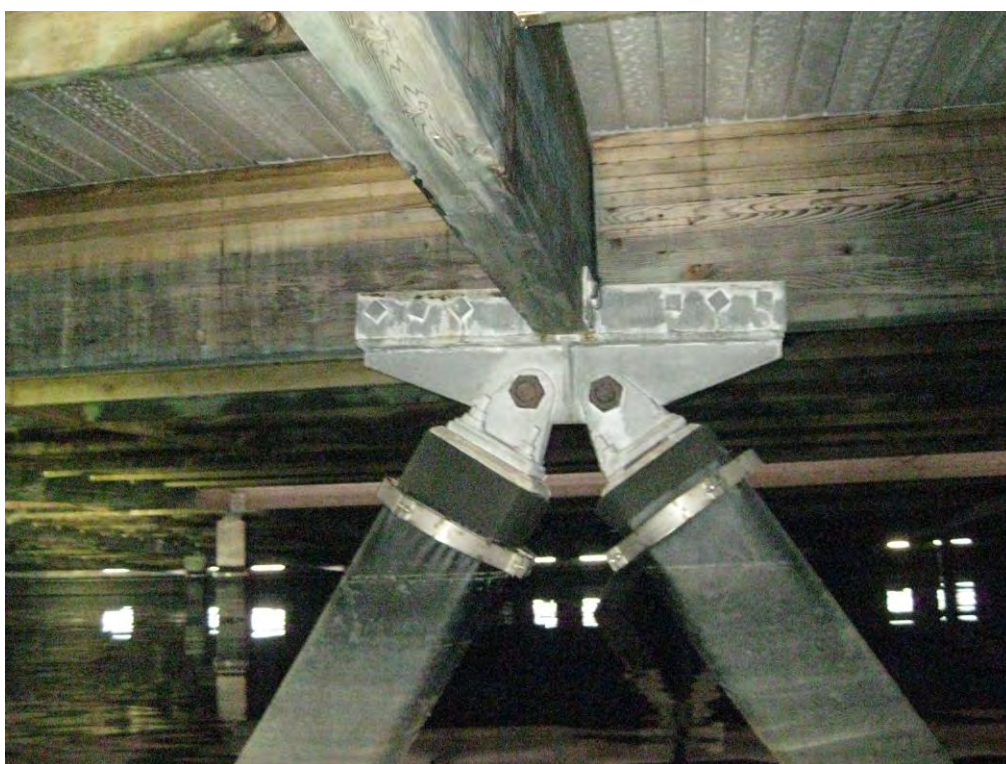
TYPICAL BRACED FRAME CONNECTION  
(CORRODED NUTS AND BOLTS)
