Peters Canyon and Vista Panorama Reservoir Condition Assessment

Subject: **GEOTECHNICAL AND SEISMIC HAZARD ASSESSMENT REPORT**
Existing 6-Million Gallon Reservoir
East Orange County Water District
Handy Creek Road
Orange, California

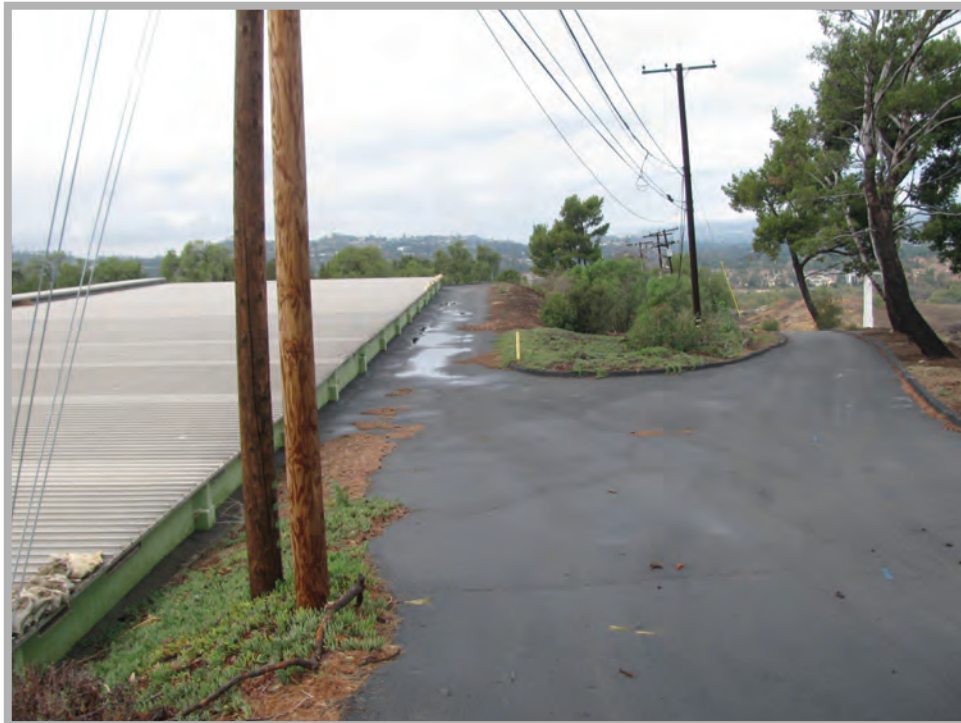
Photo B.1
Peters Canyon Reservoir Roof Looking South West

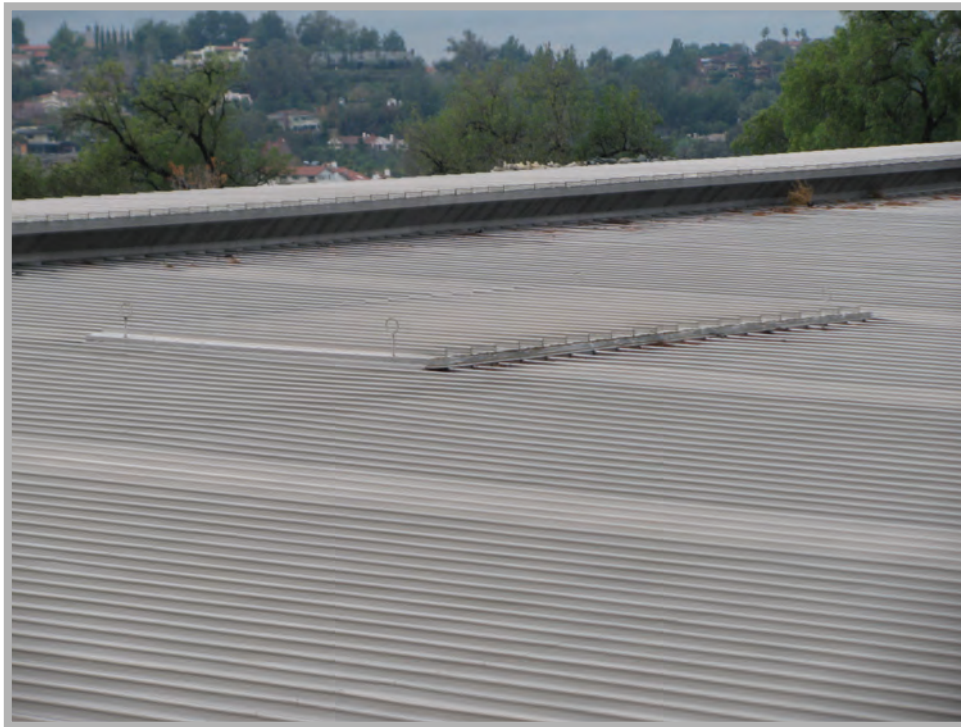
Photo B.2
Peters Canyon Reservoir Roof and North Wall

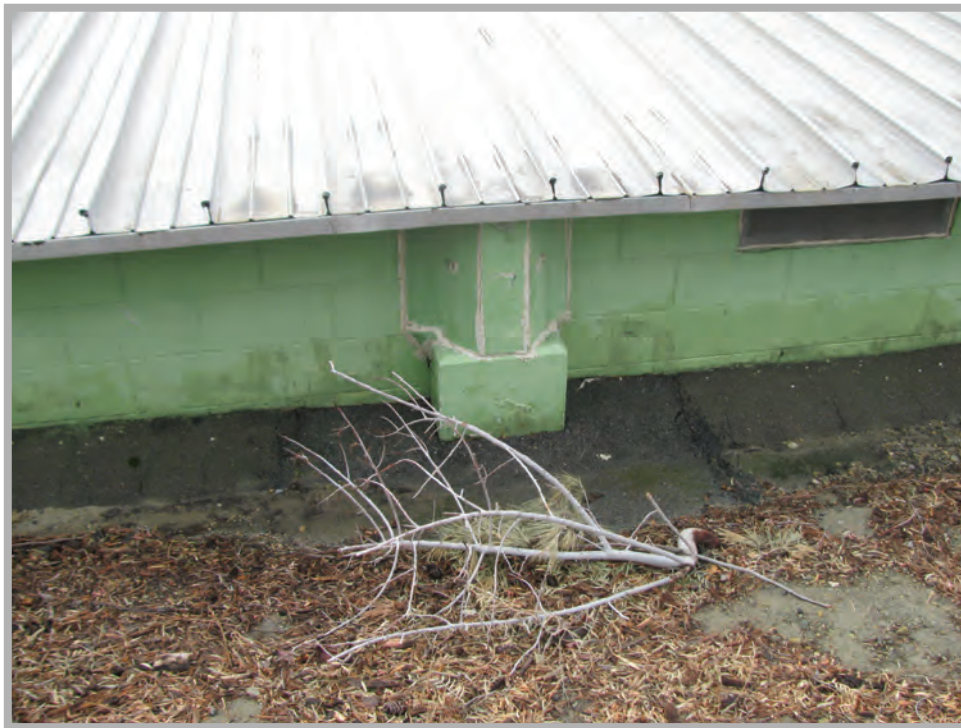
Photo B.3
Peters Canyon Reservoir Roof Central Vent

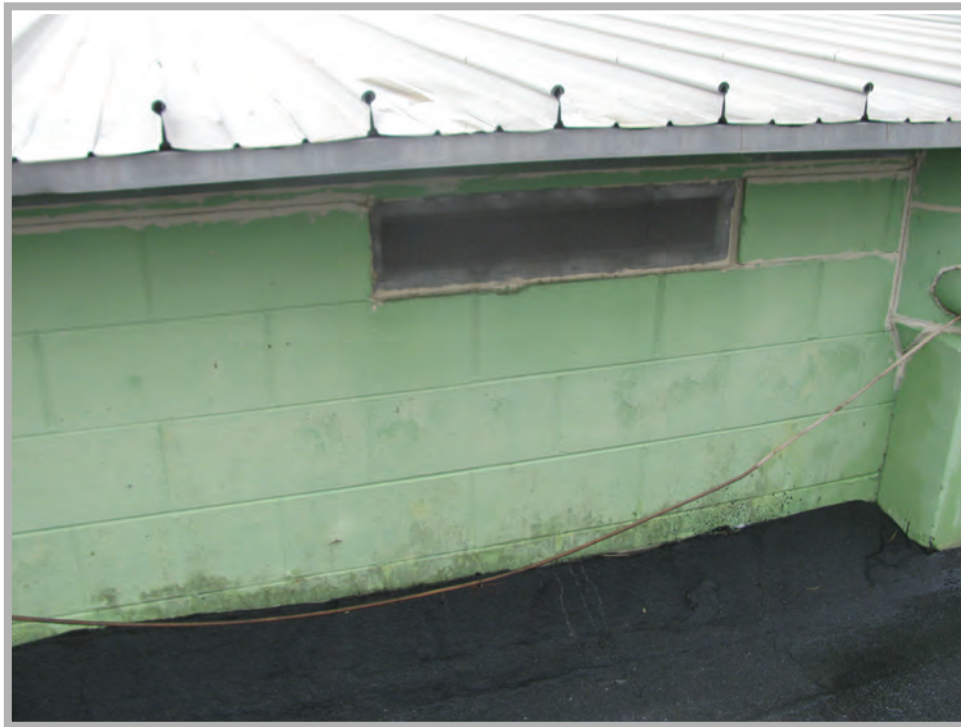
Photo B.4
Peters Canyon Reservoir Typical Pilaster

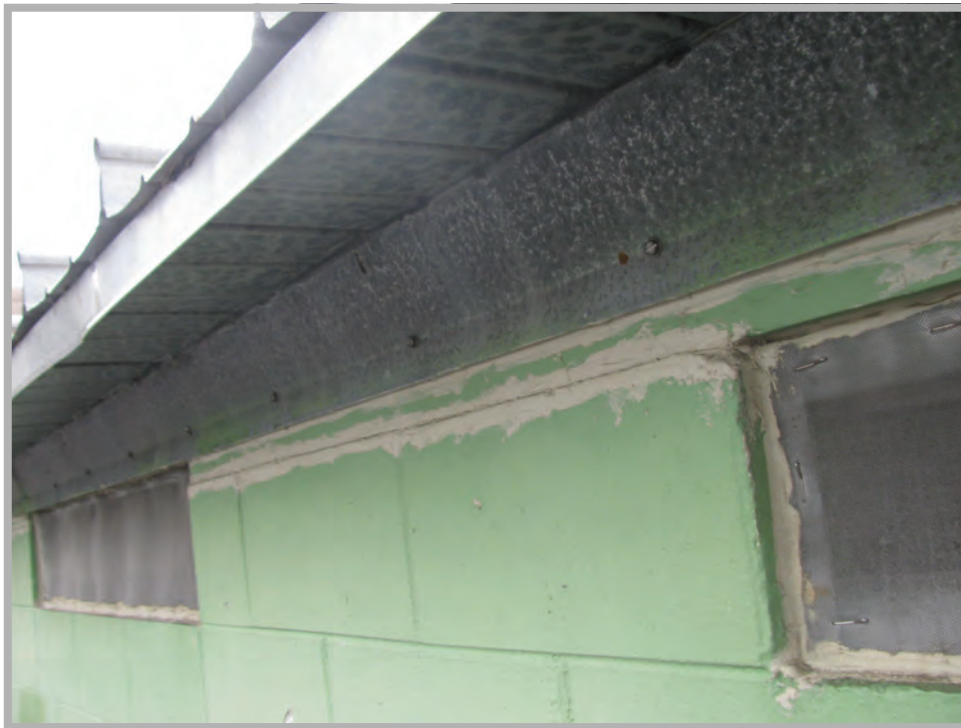
Photo B.5
Peters Canyon Reservoir CMU wall Vent and Zip-Rib Roof

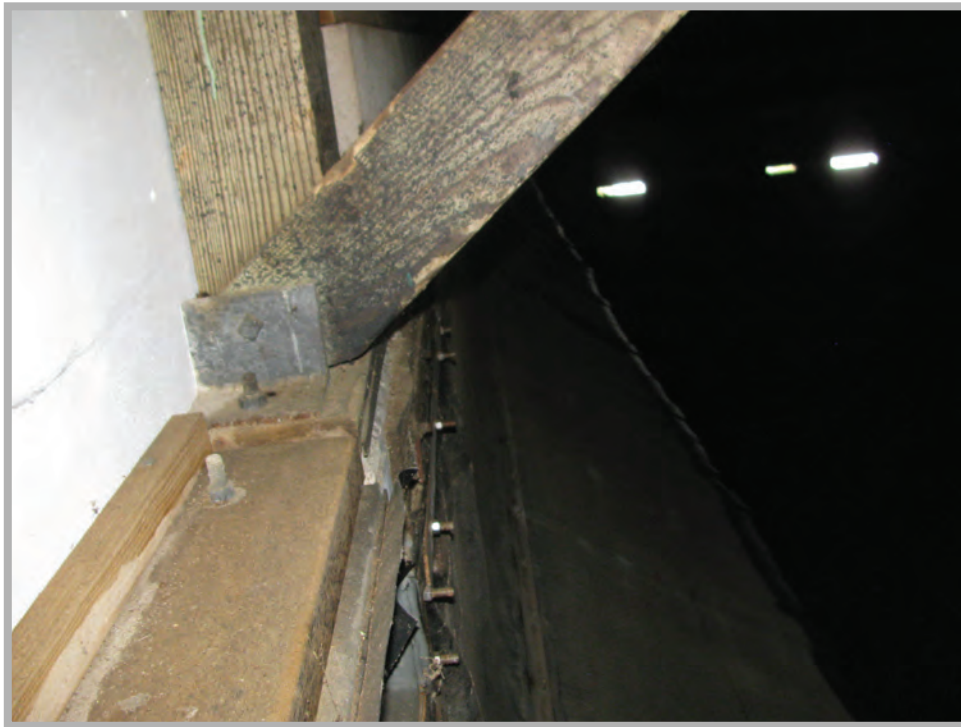
Photo B.8
Peters Canyon Reservoir Typical Purlin and brace at Perimeter Wall

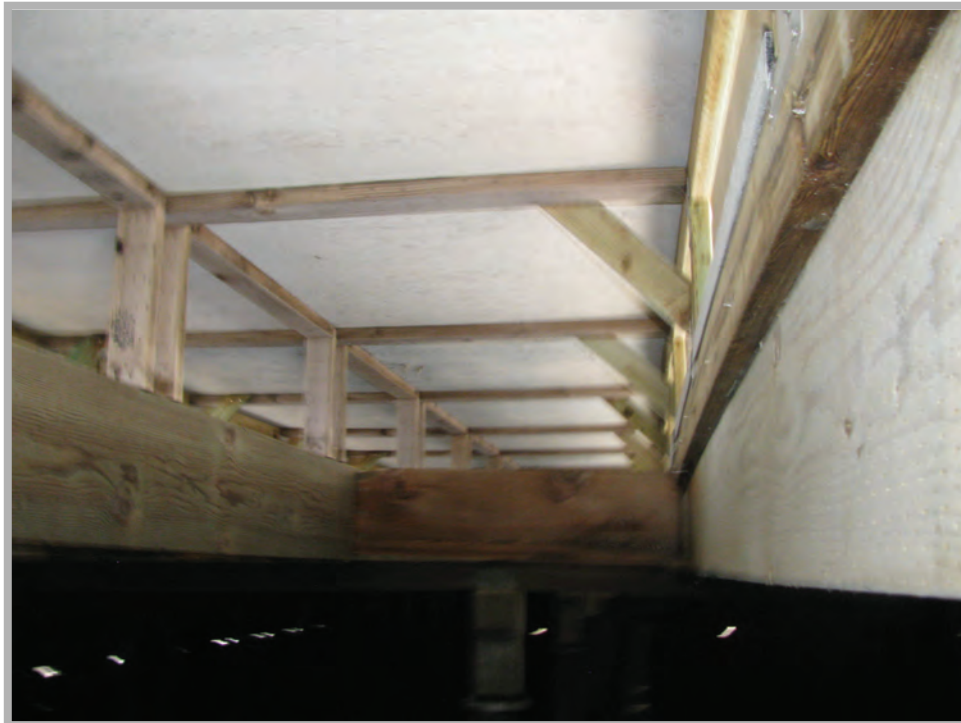
Photo B.9
Peters Canyon Reservoir Typical Brace Bottom Connection at Perimeter wall

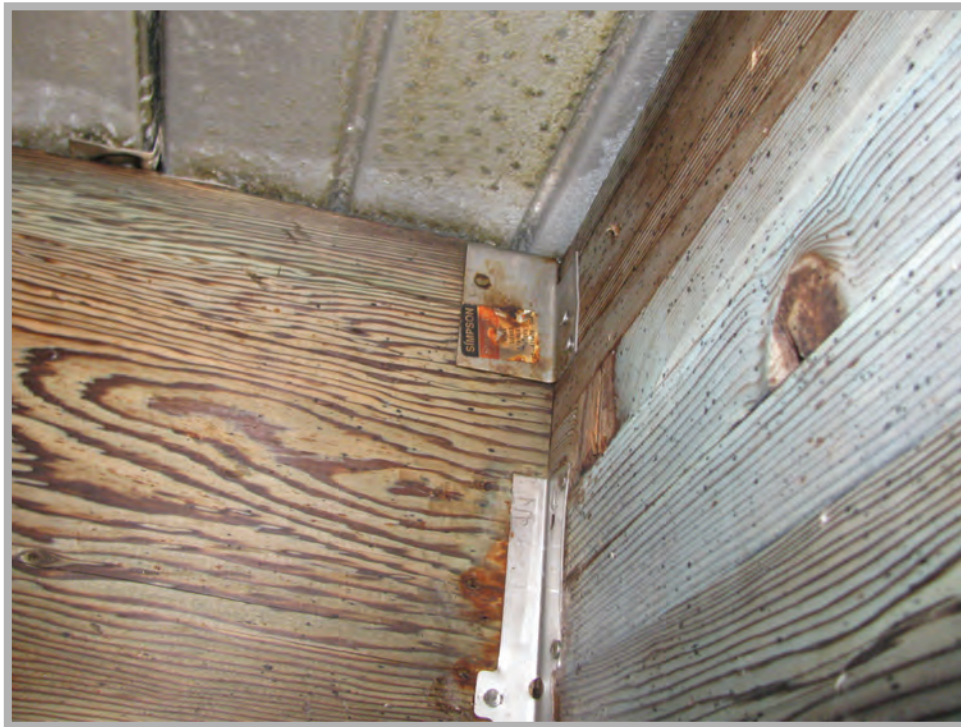
Photo B.10
Peters Canyon Reservoir Typical Framing at Central Vent

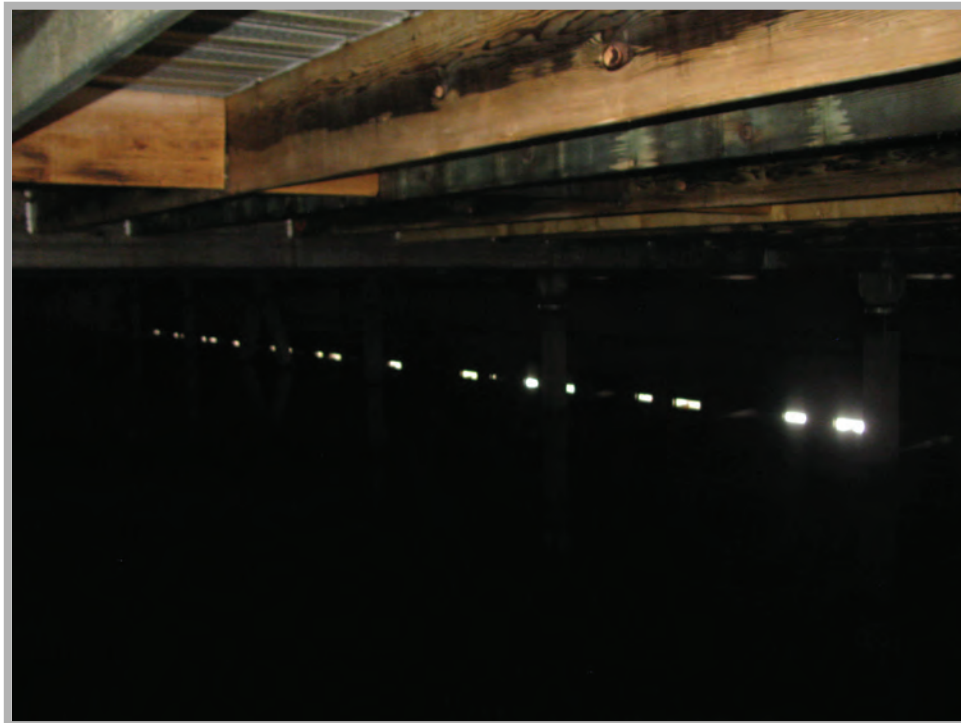
Photo B.11
Peters Canyon Reservoir Purlin to Glulam Connection

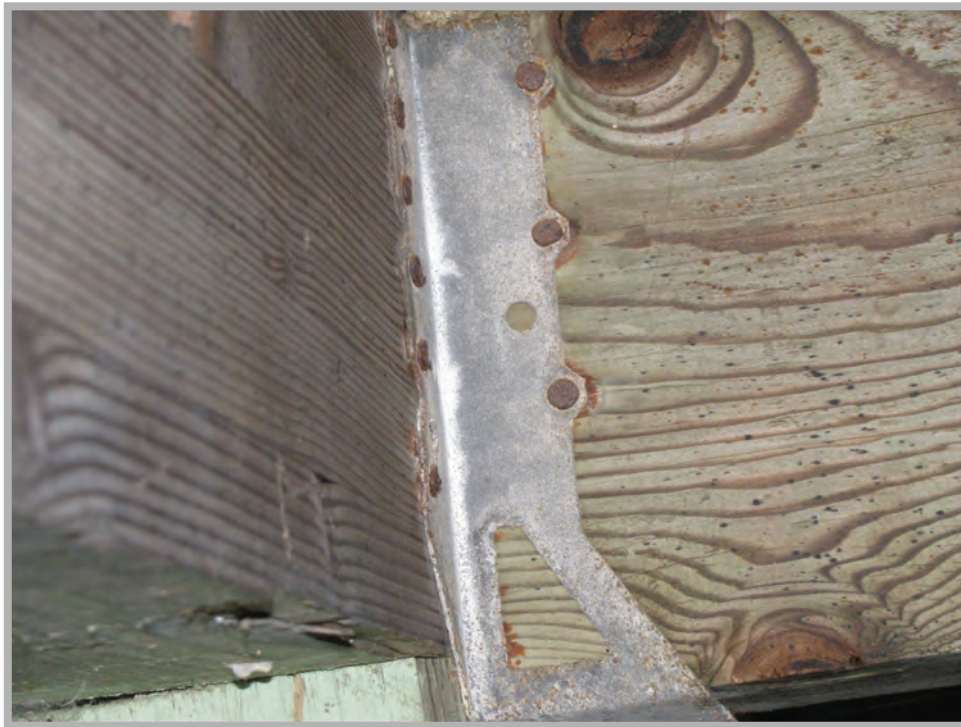
Photo B.14
Peters Canyon Reservoir Zip-Rib Interior Clip Connection
