# Peters Canyon 6MG Reservoir

Instrumentation Monitoring May 2025

Subject: Instrumentation Monitoring Report  
Peters Canyon 6 MG Reservoir  
Orange County, CA

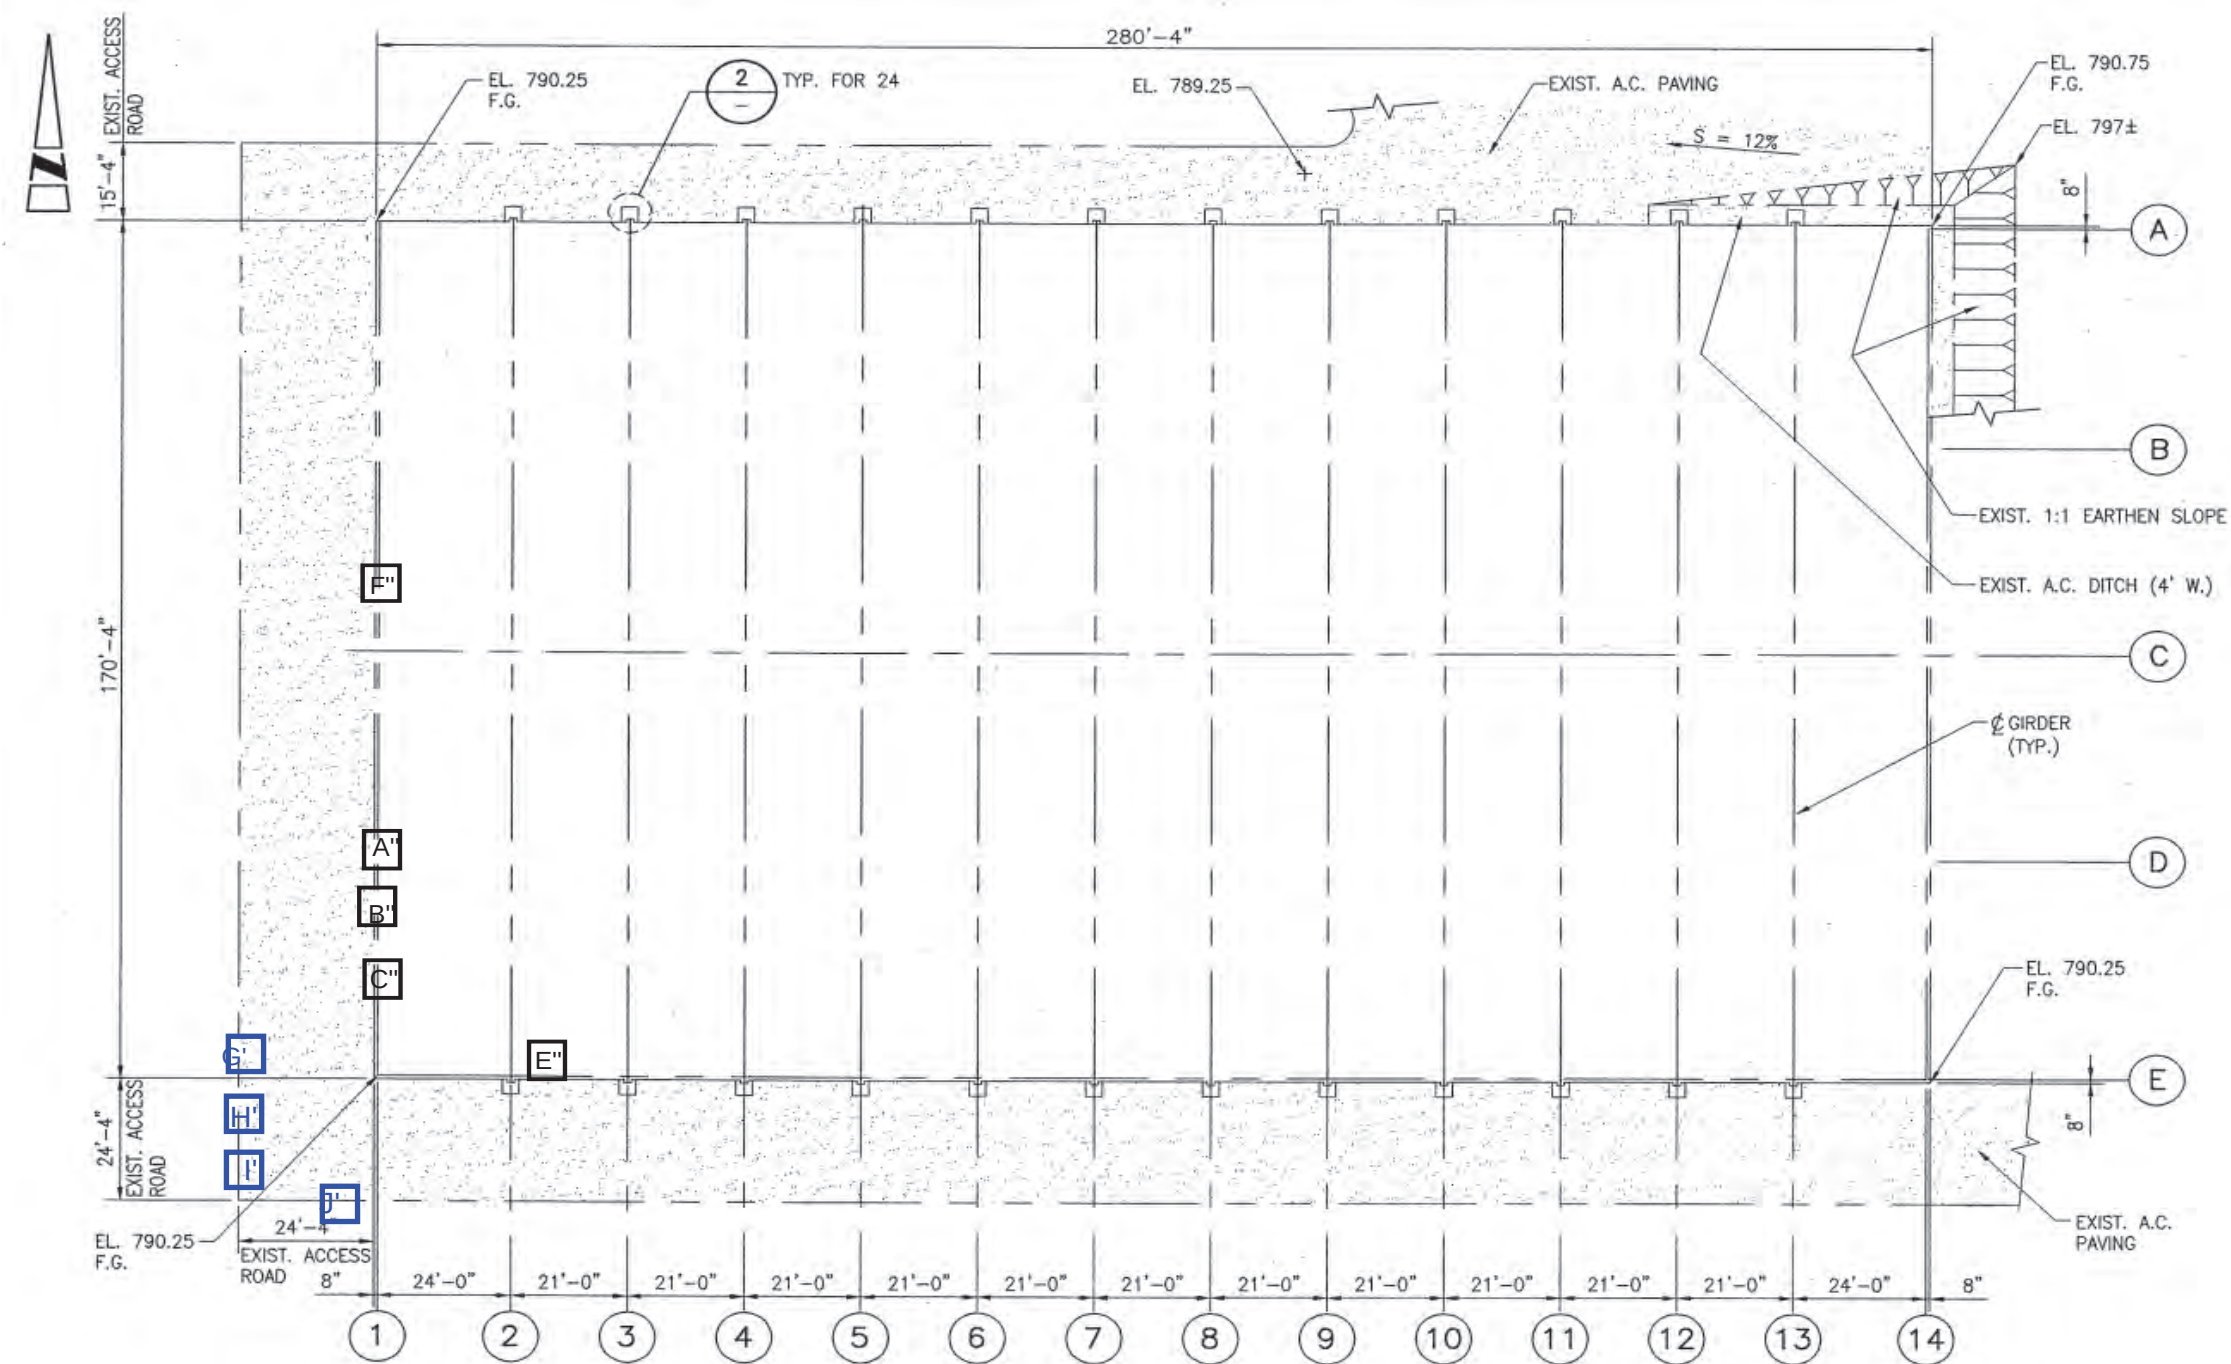
Crack Monitoring Plan

- A'** Reservoir Wall Crack Monitor Location.  
Removed in December 2024\*
- G'** Curb Crack Monitor Location
- A''** Reservoir Wall Crack Monitor Location.  
Installed in December 2024

\* Refer to previous reports for crack monitors installed in 2023 and nomenclature

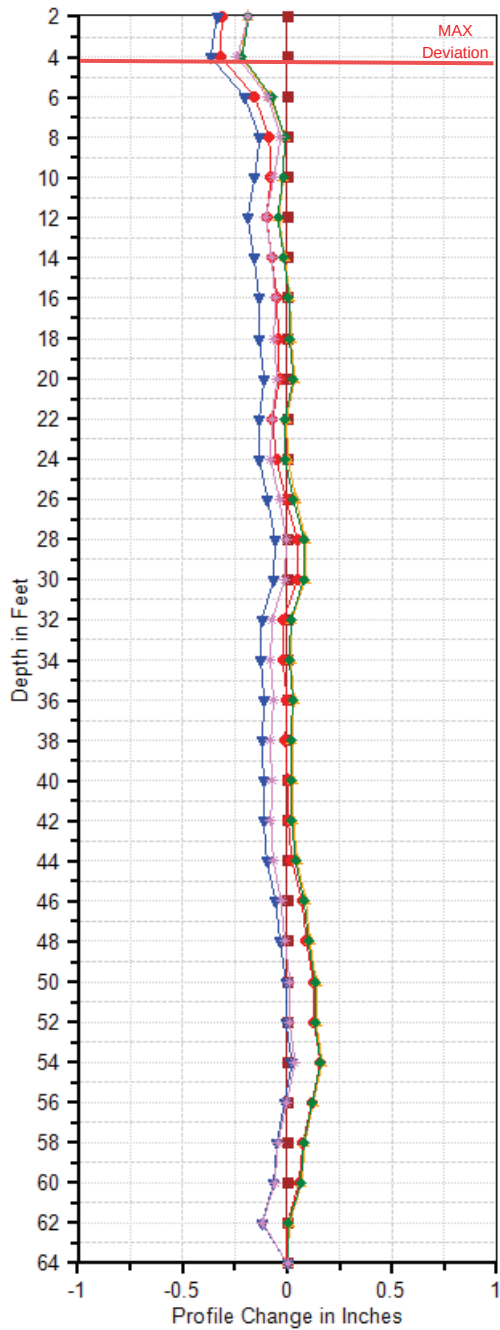
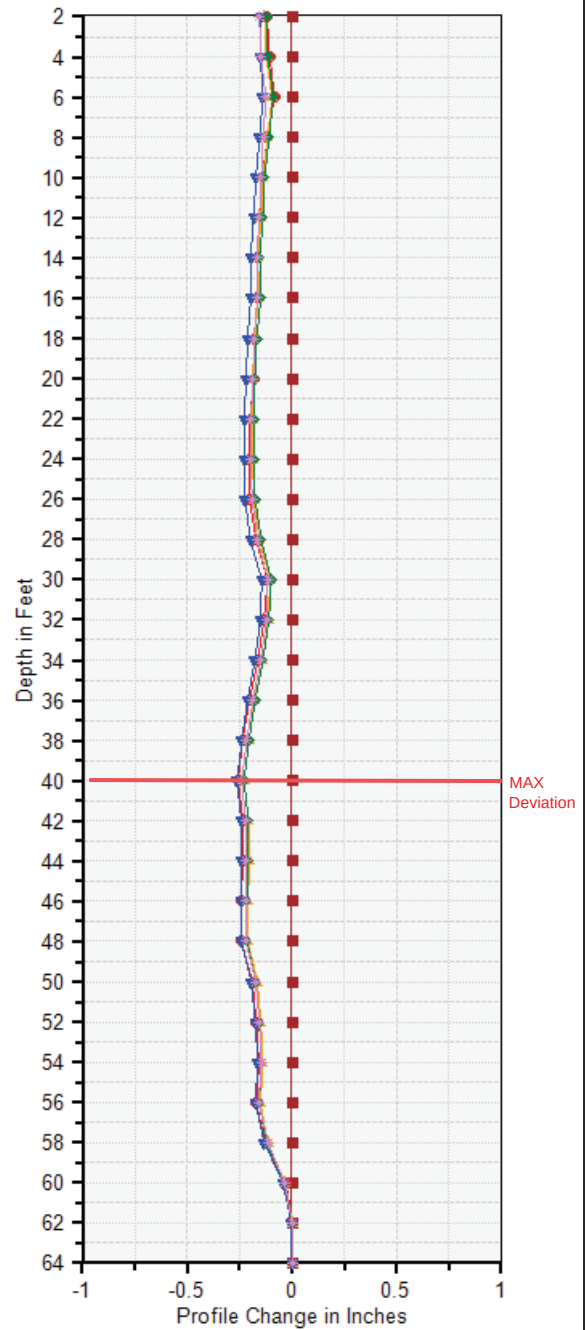
### Profile Change from Baseline A-21-1 A Axis

On May 22, 2025, AECOM conducted instrumentation monitoring of the existing monitors at the project site including inclinometers, crack monitors and groundwater monitoring wells. The recorded data indicate no significant changes on the readings compared to the previous readings or the baseline established in 2021. Therefore, there are no concerns regarding the structural integrity of the reservoir at this point.

Inclinometer Reading May 2025  
Boring ID: A-21-1

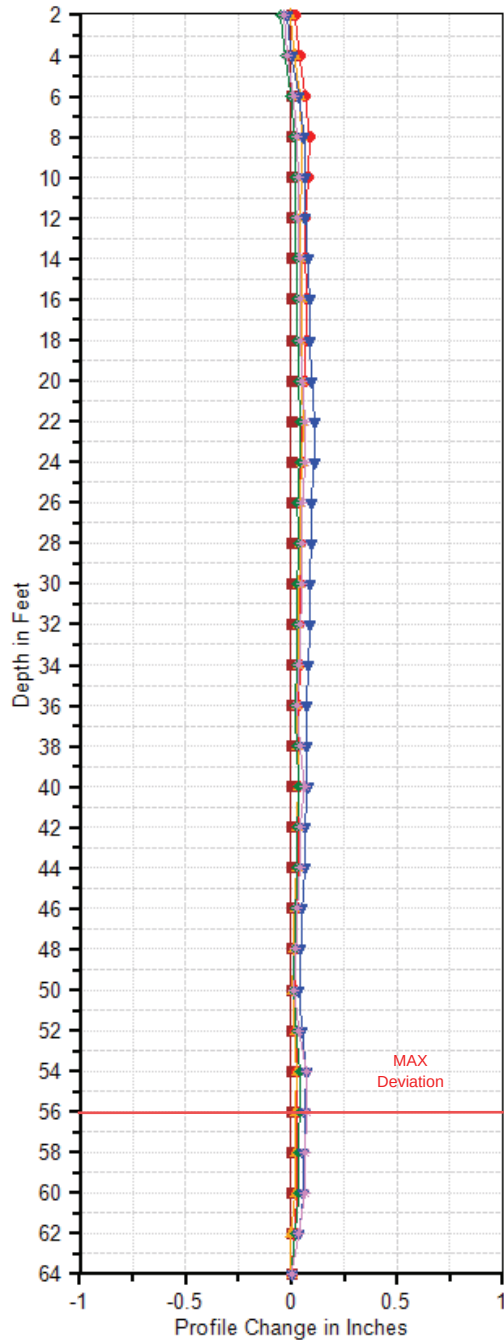
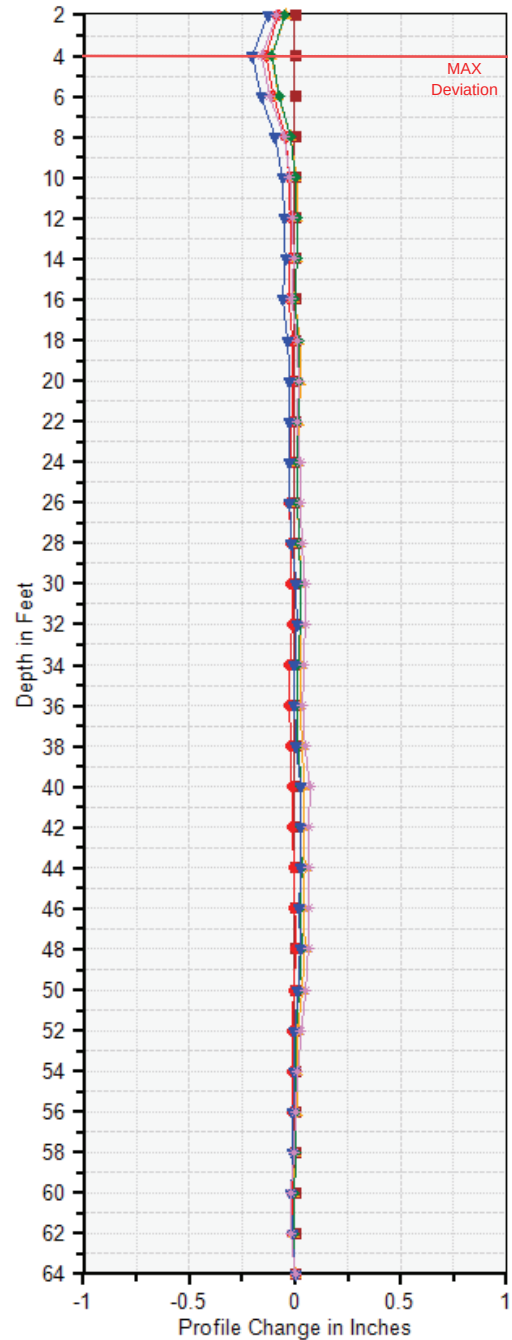
### Profile Change from Baseline A-21-3 A Axis

Inclinometer Reading May 2025

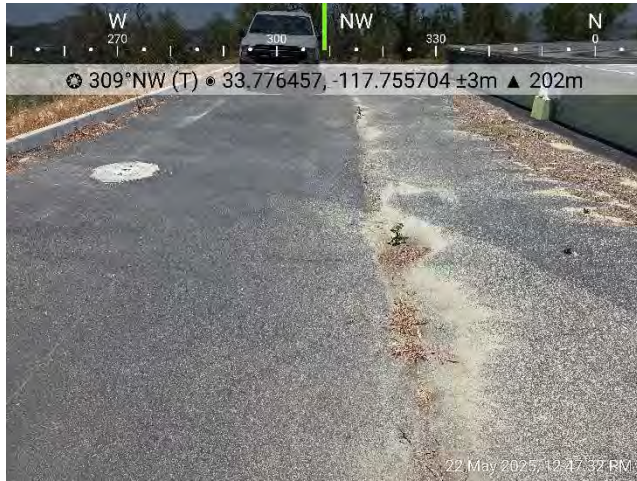
**view:** South end of site.

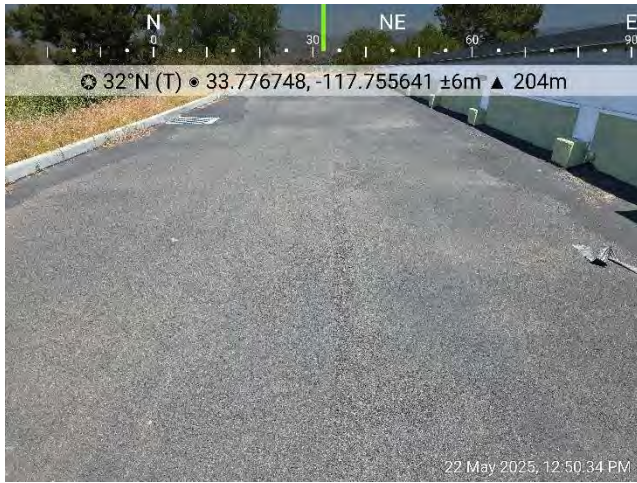
During the recent site visit, AECOM's field engineer performed a follow up visual inspection of the asphalt around the site, specifically the southwest corner of the reservoir for any visible distresses around the reservoir. Besides some surficial cracks throughout the site and some low-level cracks (less than 1 inch) predominantly between the asphalt and the southwest portion of the concrete curb, no significant alligator or fatigue cracking of the asphalt was observed during this recent visit. The low-level cracks appear very uniform and are possibly a result of placing asphalt in separate sections. Photos of the existing asphalt surface from this site visit are presented in Appendix B-2.

**view:** Asphalt surface along the west end of the site

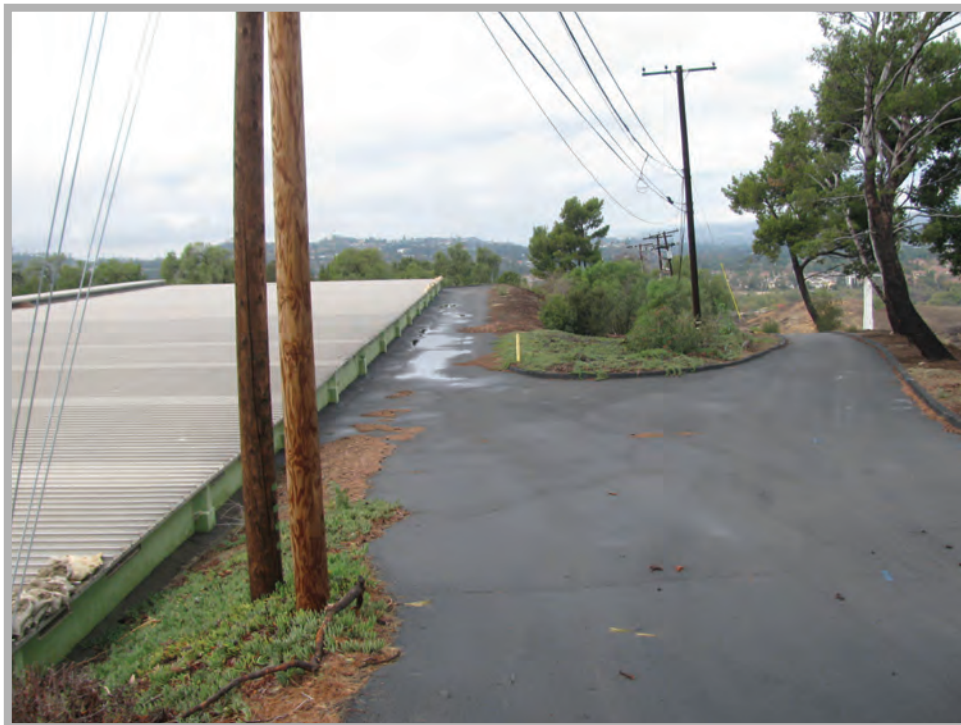
Photo B.2  
Peters Canyon Reservoir Roof and North Wall

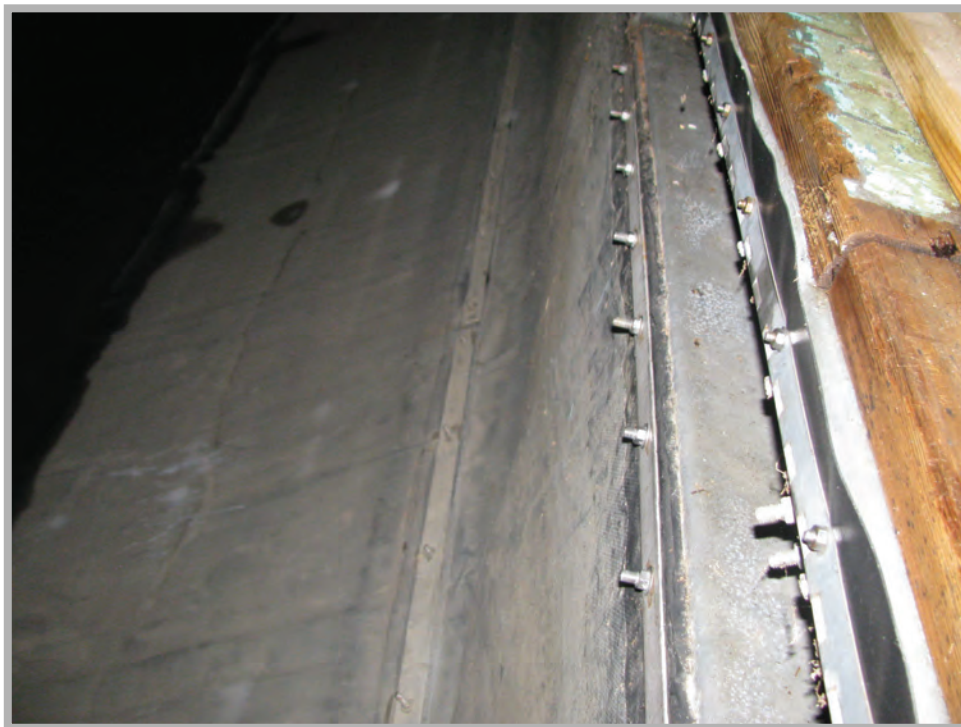
Photo B.13  
Peters Canyon Reservoir Hypalon Liner

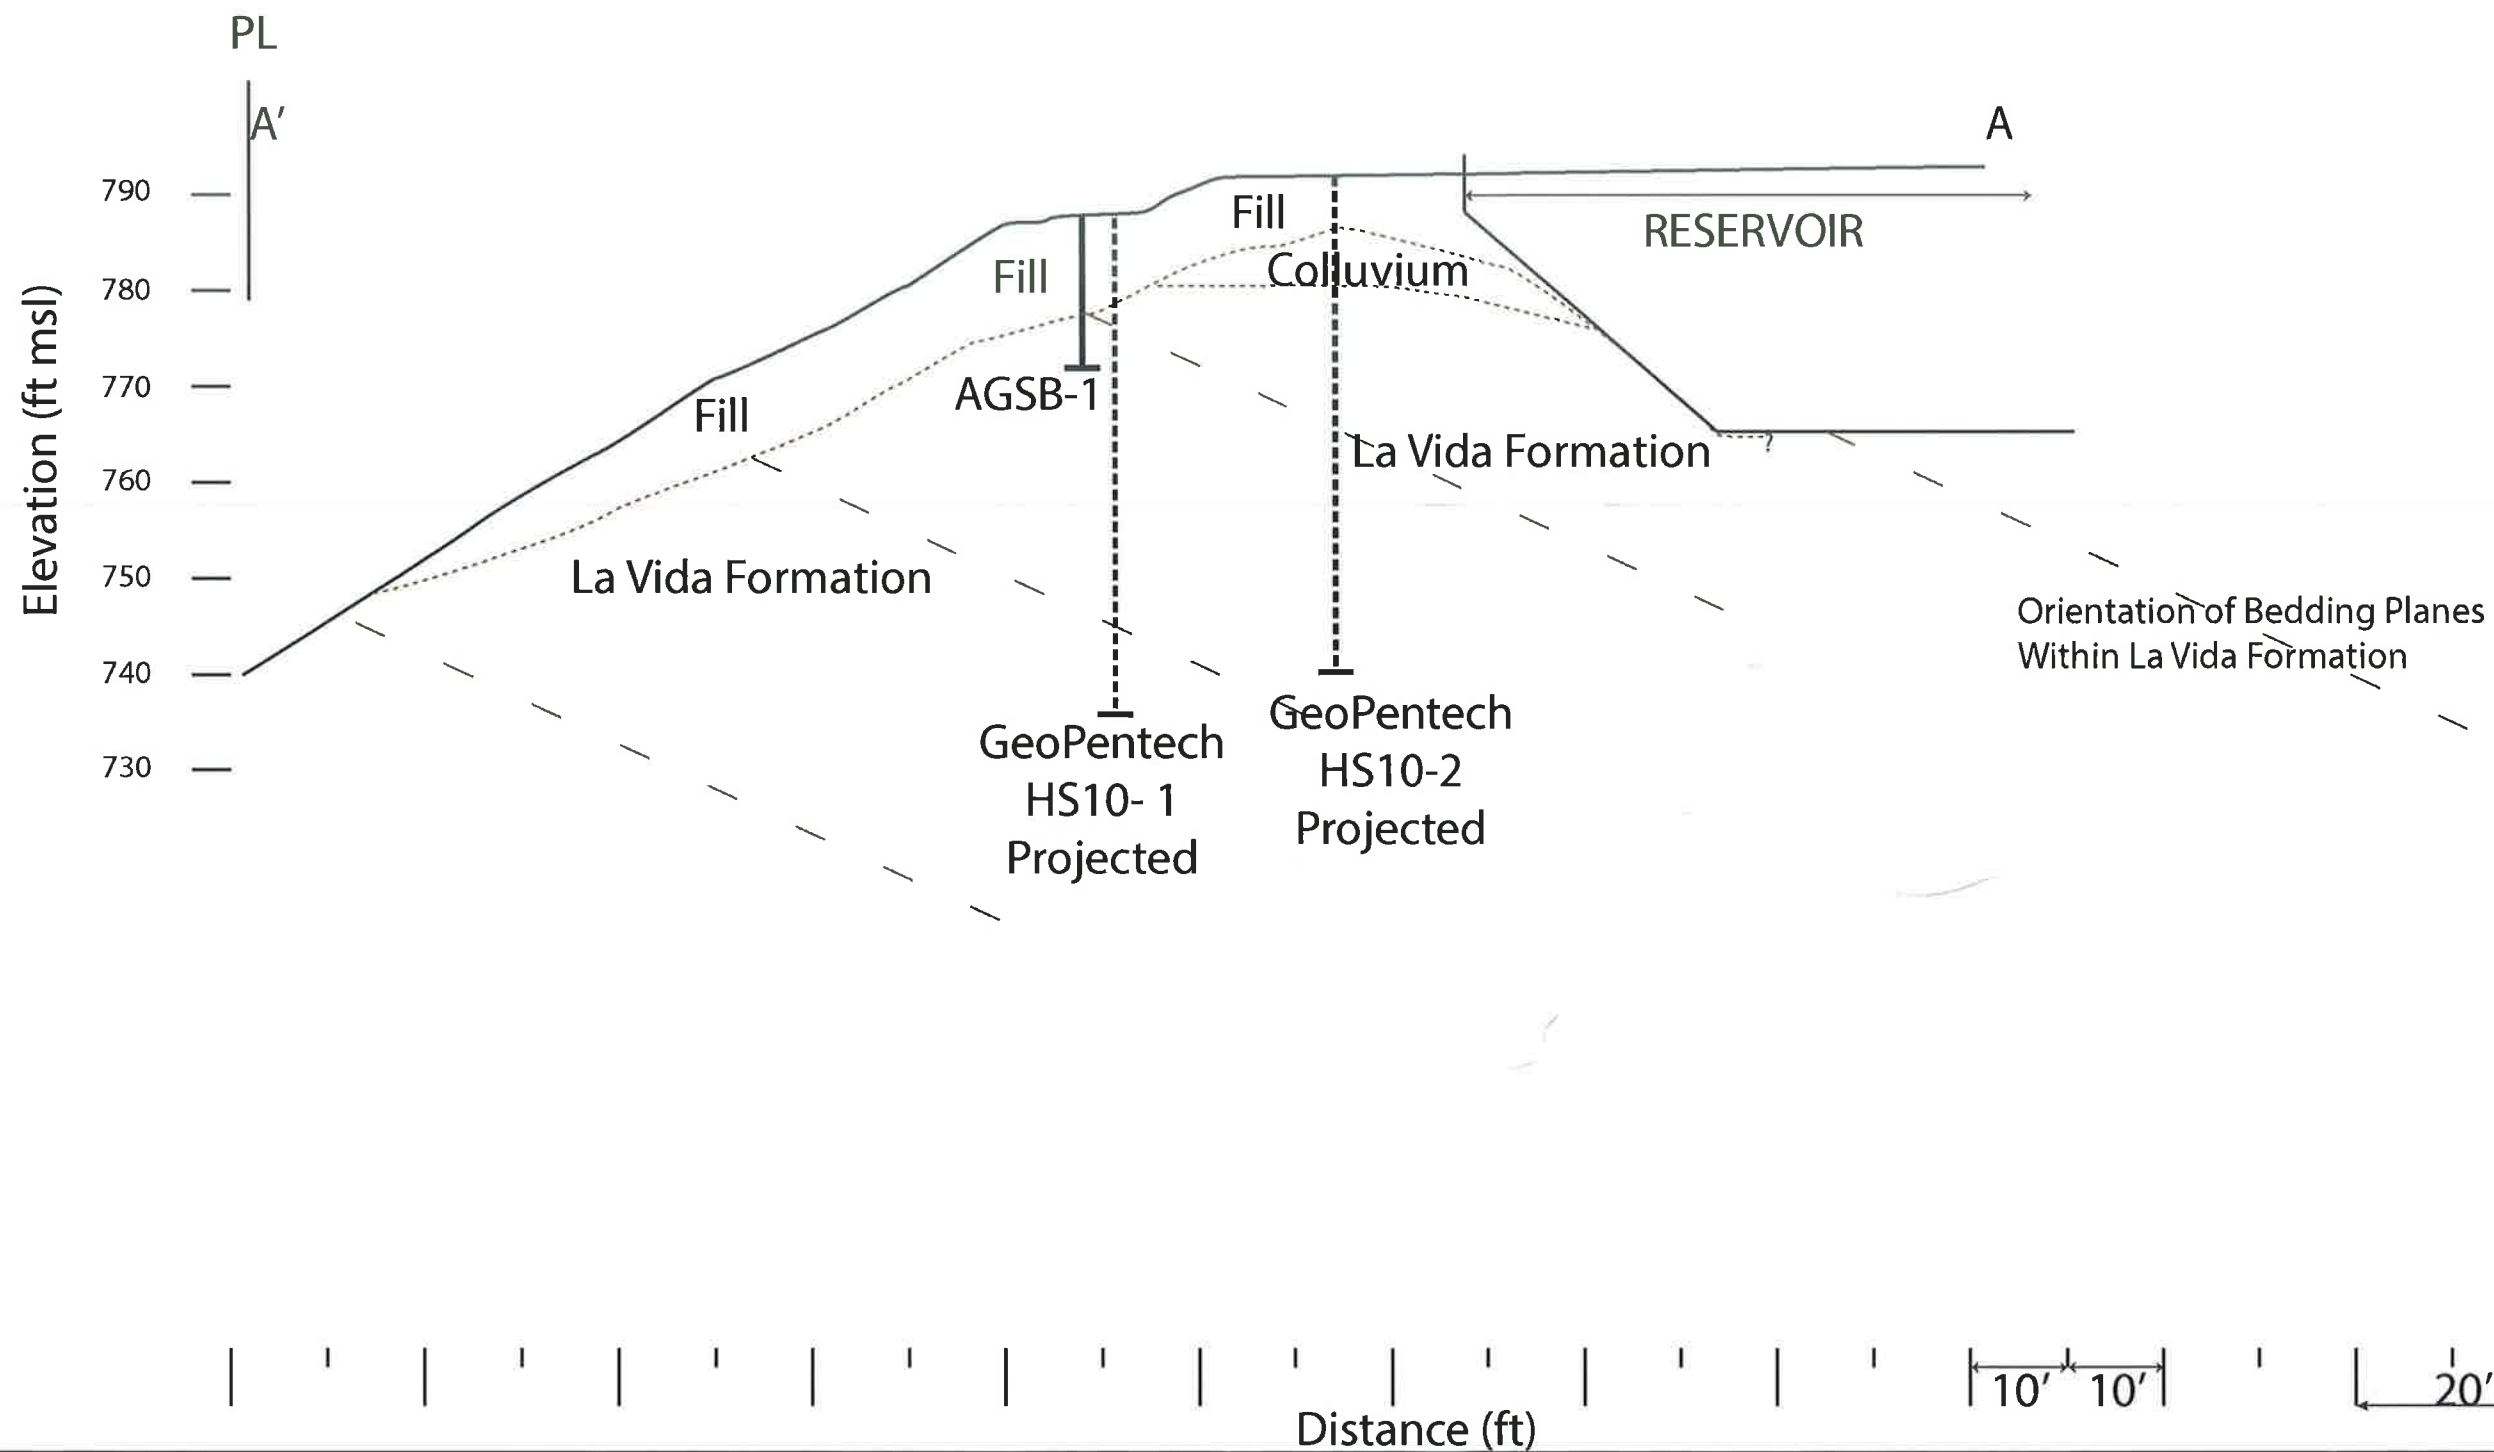
**Plate 3**

GeoPentech advanced soil borings along the southern area the project site in 2010 at approximate locations depicted on Plate 3 to evaluate groundwater seepage conditions associated with a shallow hillside slope failure. Their borings extended to depths of 51-feet below the ground surface and encountered similar fill soil, colluvium, and light- to dark gray siltstone sediments identified as La Vida/Puente Formation. Groundwater was not observed in the soil borings by GeoPetech personnel at the time of drilling, and monitoring wells were constructed in each of the borings for long-term monitoring. Information provided from East Orange County Water District personnel indicated that groundwater has not been observed in these monitoring wells to date.

Five different geologic cross-sections (Sections A-A' thru E-E') were developed to depict the underlying fill soil and bedrock conditions at the locations depicted on Plate 3. These cross-sections (see Plates 4 thru 6) were used to assist in selection of critical sections for the slope stability analyses (presented later in this report).

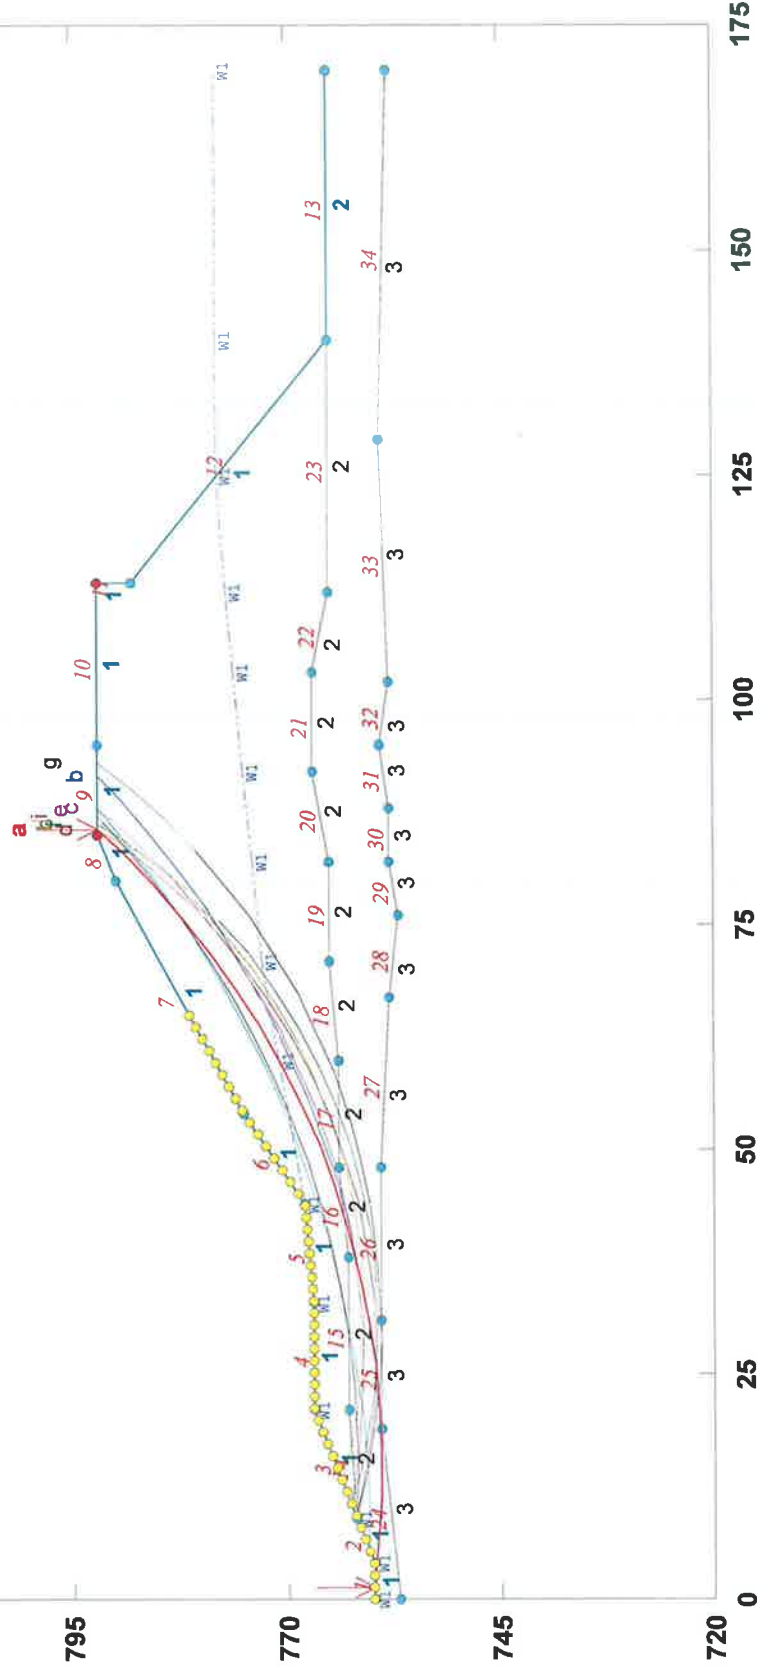
# 33615-01 Handy Creek Rd. Reservoir Section D-D' - Moderate Leaking-Seismic

| Section | Case # | Description | Factor-of-Safety<br>(Static) | Factor-of-Safety<br>(Pseudostatic) |
|---|---|---|---|---|
| D-D' | 3 | Moderate leak | 1.448 | 0.978 |

GSTABL7 v.2 FSmin=0.978  
Safety Factors Are Calculated By GLE (Spencer's) Method (0-1)

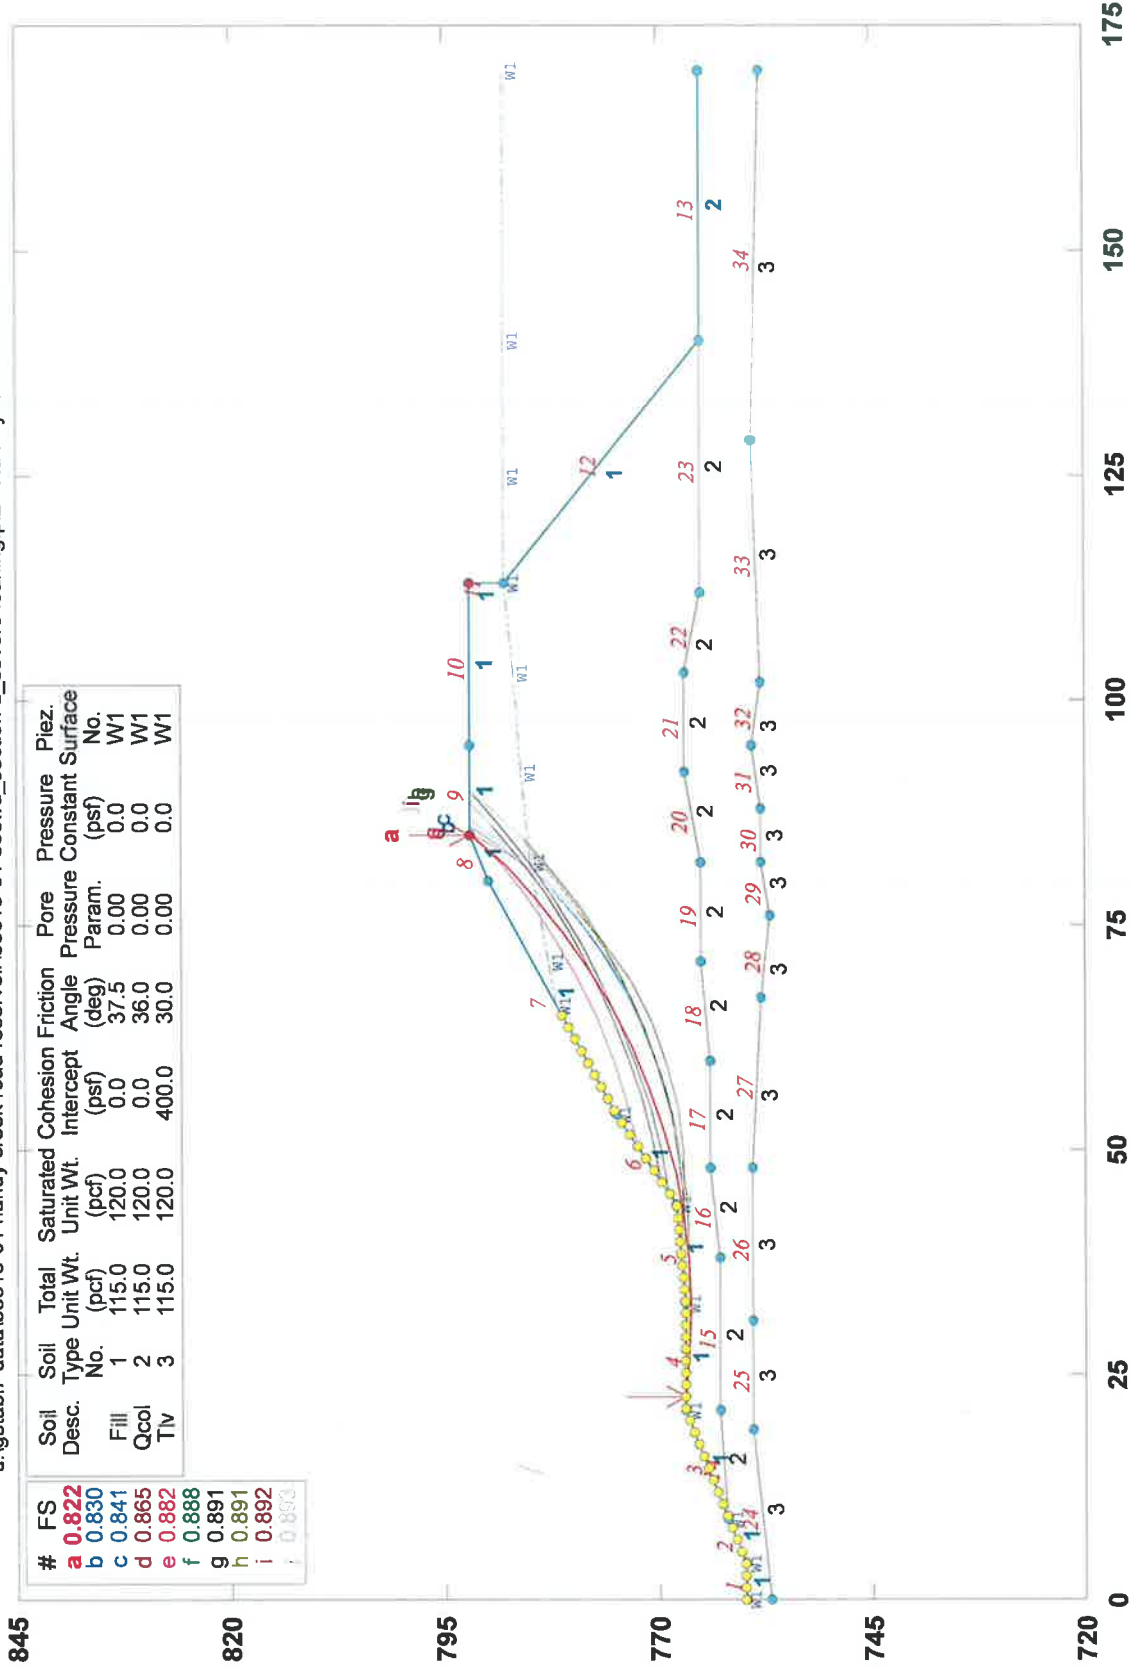
# 33615-01 Handy Creek Rd. Reservoir Section D-D' - Severe Leaking - Static

| Section | Case # | Description | Factor-of-Safety<br>(Static) | Factor-of-Safety<br>(Pseudostatic) |
|---|---|---|---|---|
| D-D' | 4 | Severe leak | 0.822 | 0.560 |

GSTABL7 v.2 FSmin=0.822  
Safety Factors Are Calculated By GLE (Spencer's) Method (0-1)

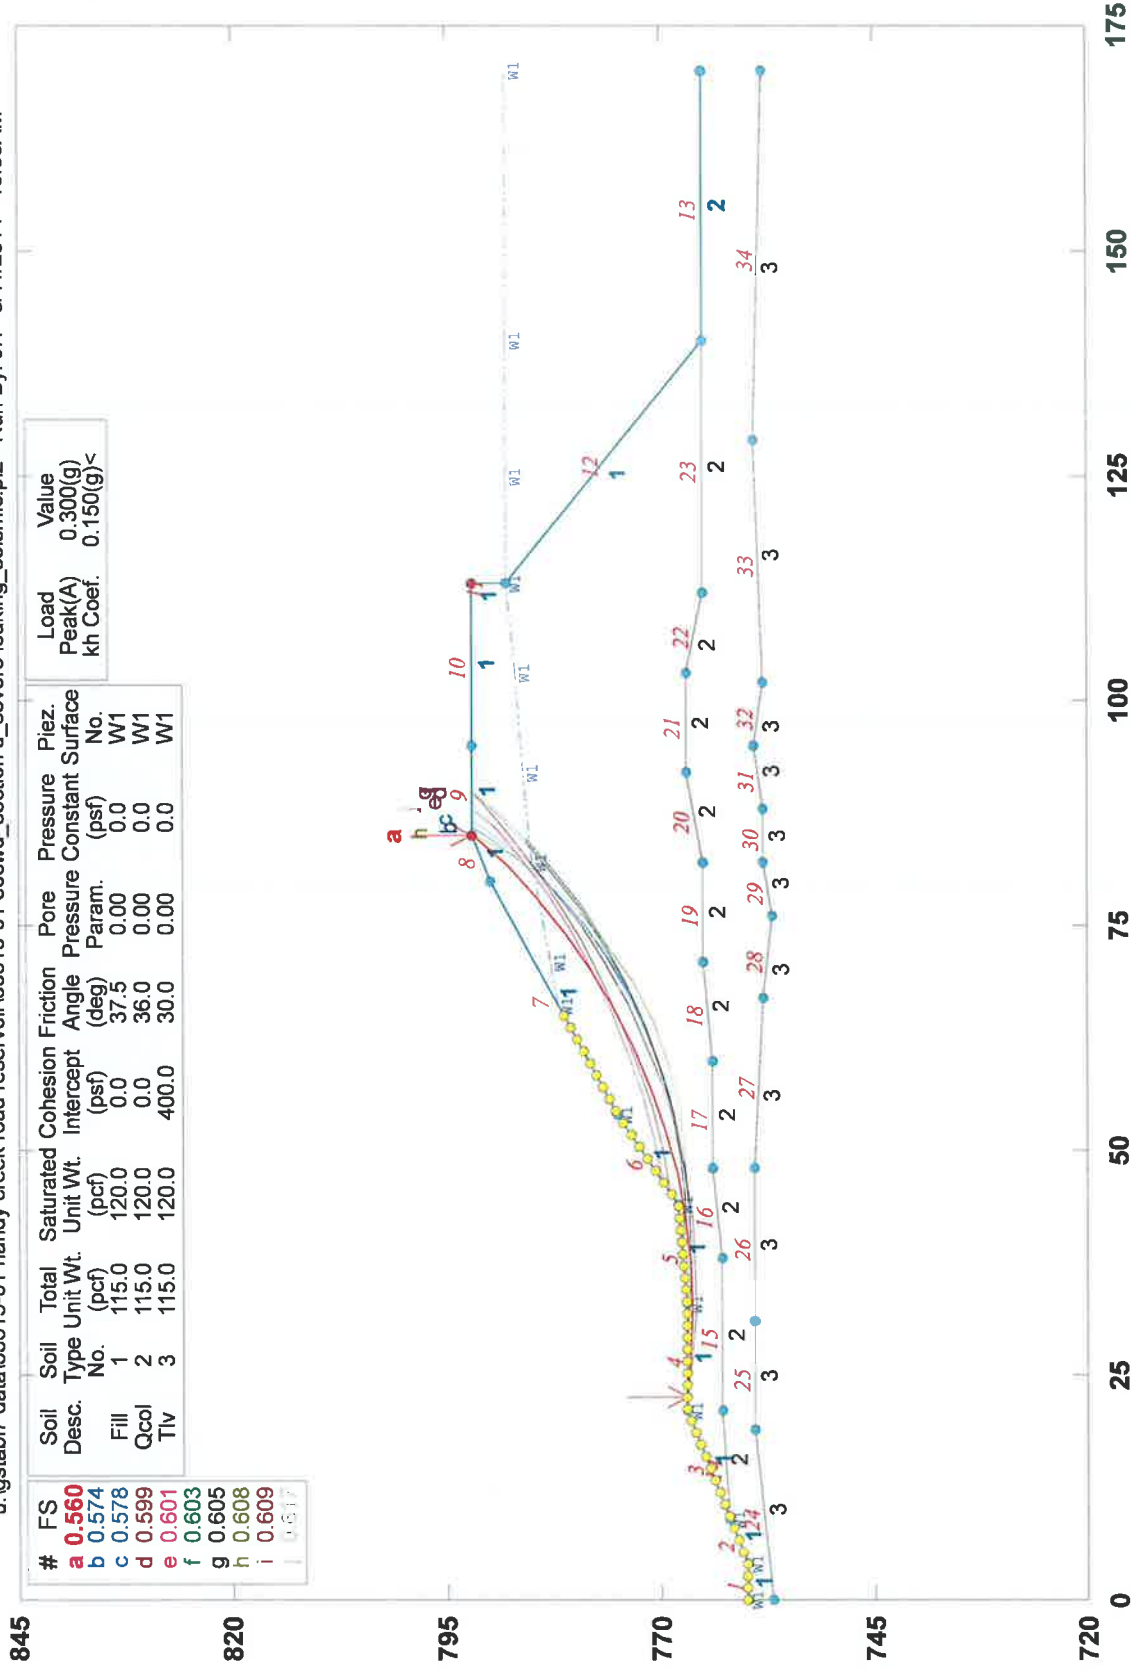
# 33615-01 Handy Creek Rd. Reservoir Section D-D' - Seismic

GSTABL7 v.2 FSmin=0.560  
Safety Factors Are Calculated By GLE (Spencer's) Method (0-1)

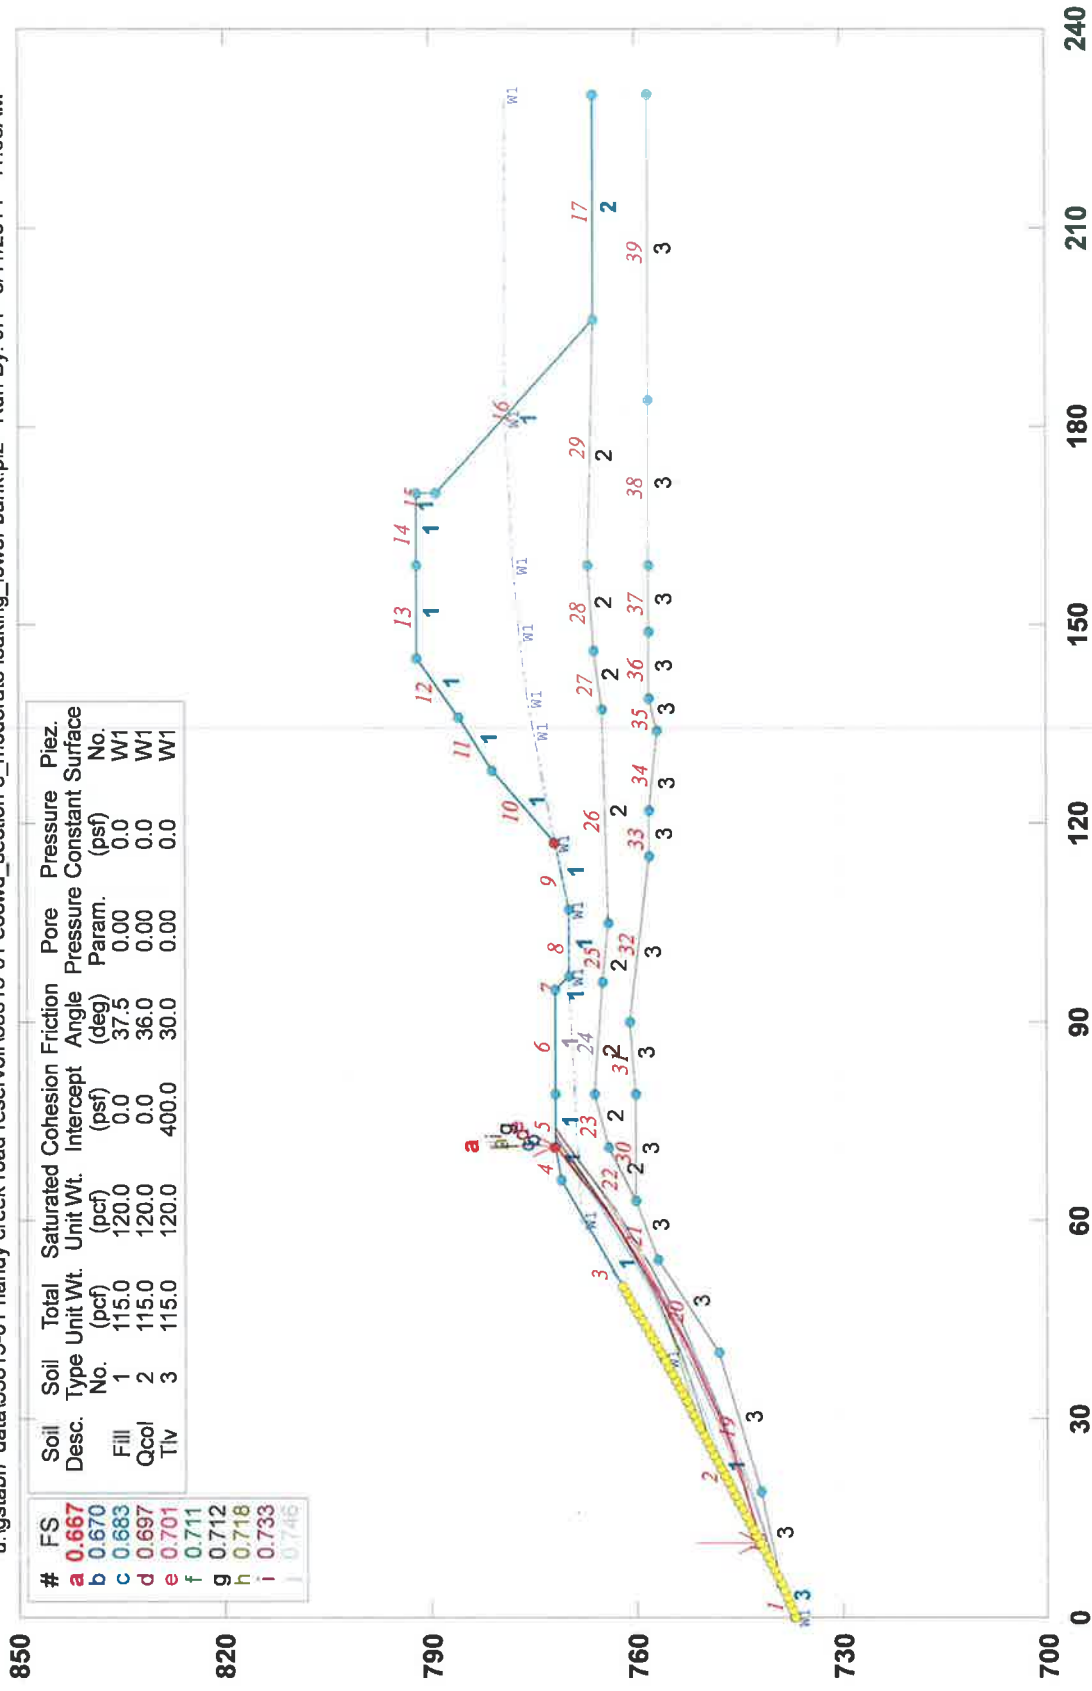
# 33615-01 Handy Creek Rd. Reservoir Section E-E'-Moderate Leak\_Low\_Static

GSTABL7 v.2 FSmin=0.667  
Safety Factors Are Calculated By GLE (Spencer's) Method (0-1)

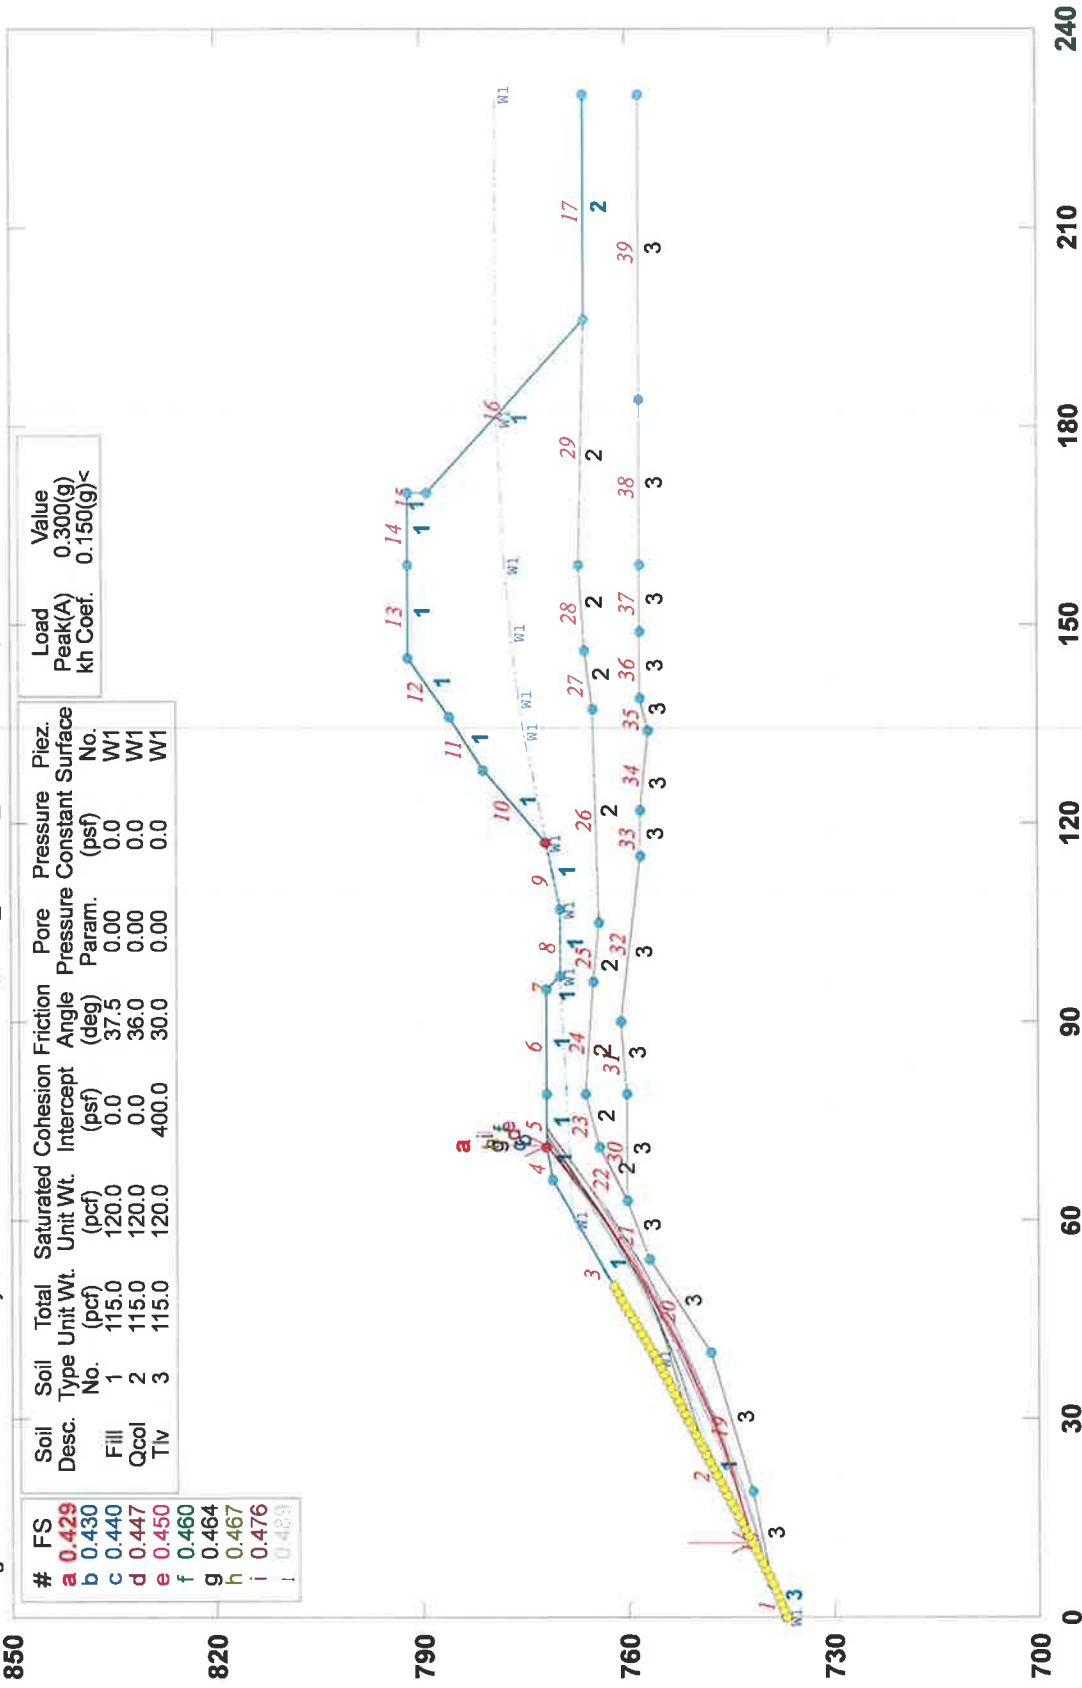
# 33615-01 Handy Creek Rd. Reservoir Section E-E'-Moderate Leak\_Low\_Seismic

GSTABL7 v.2 FSmin=0.429  
Safety Factors Are Calculated By GLE (Spencer's) Method (0-1)

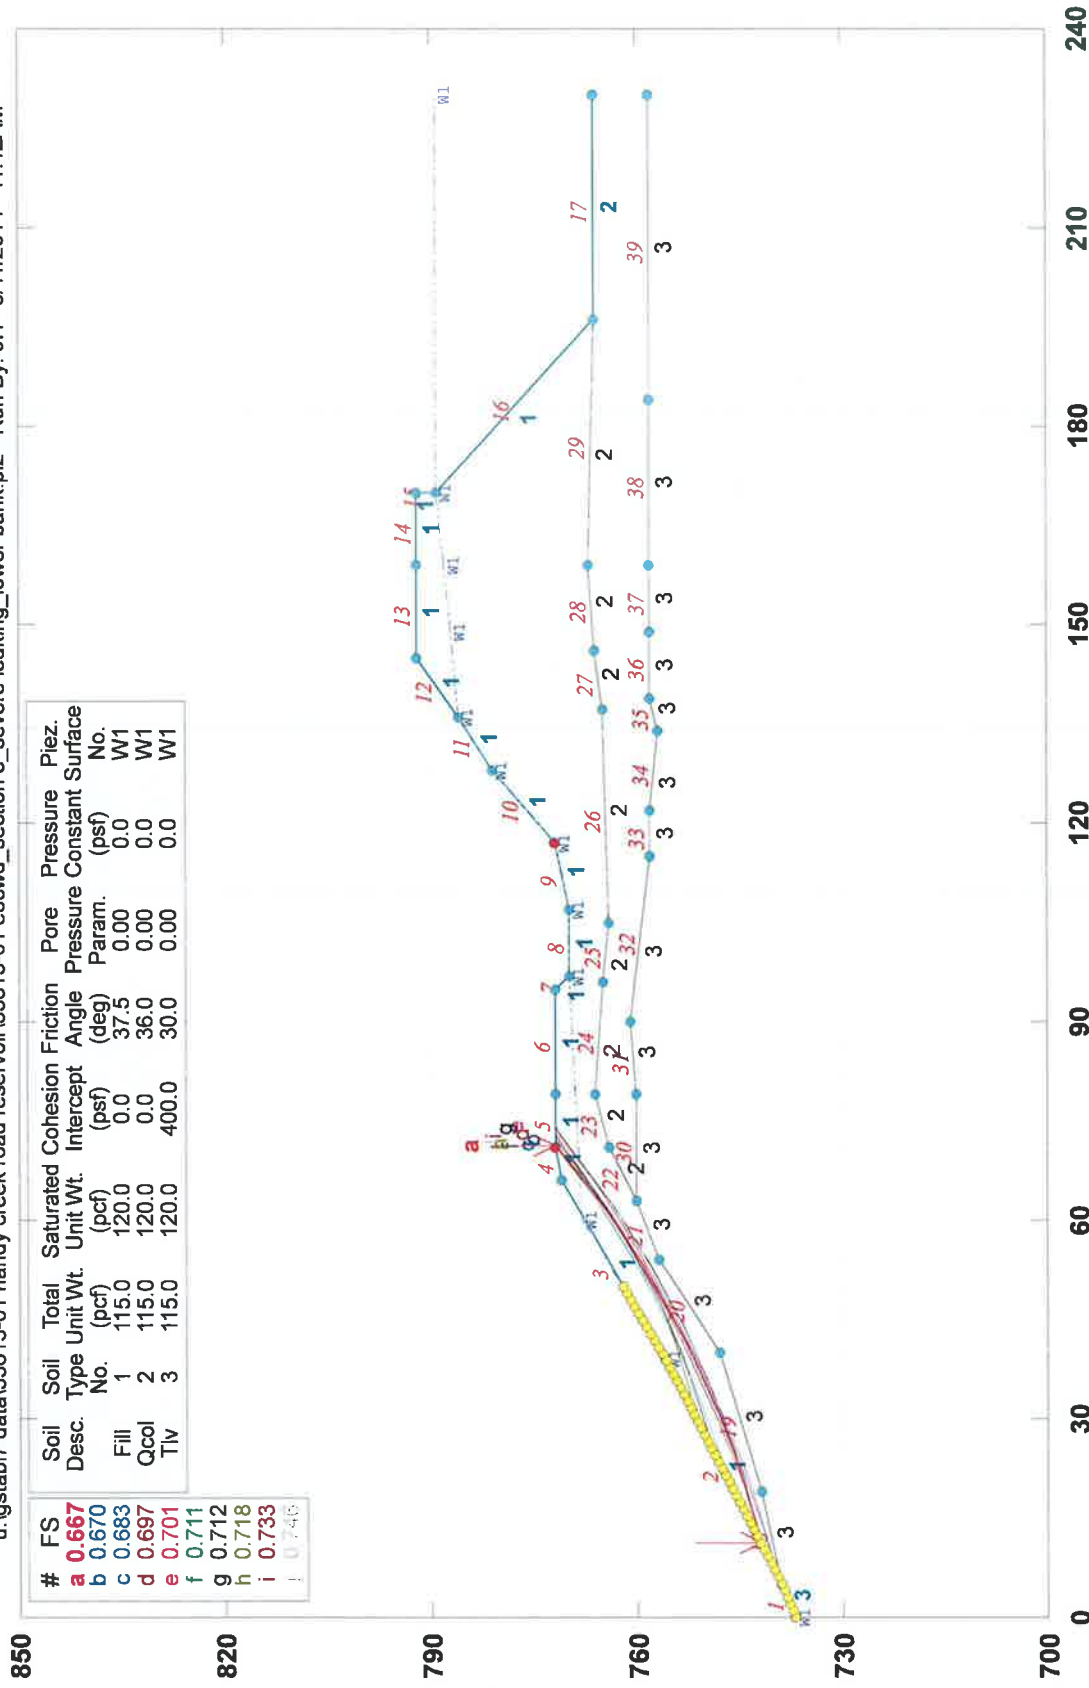
# 33615-01 Handy Creek Rd. Reservoir Section E-E' - Severe Leaking - Static

GSTABL7 v.2 FSmin=0.667  
Safety Factors Are Calculated By GLE (Spencer's) Method (0-1)
