# Peters Canyon 6MG Reservoir

Instrumentation Monitoring May 2025

Subject: Instrumentation Monitoring Report  
Peters Canyon 6 MG Reservoir  
Orange County, CA

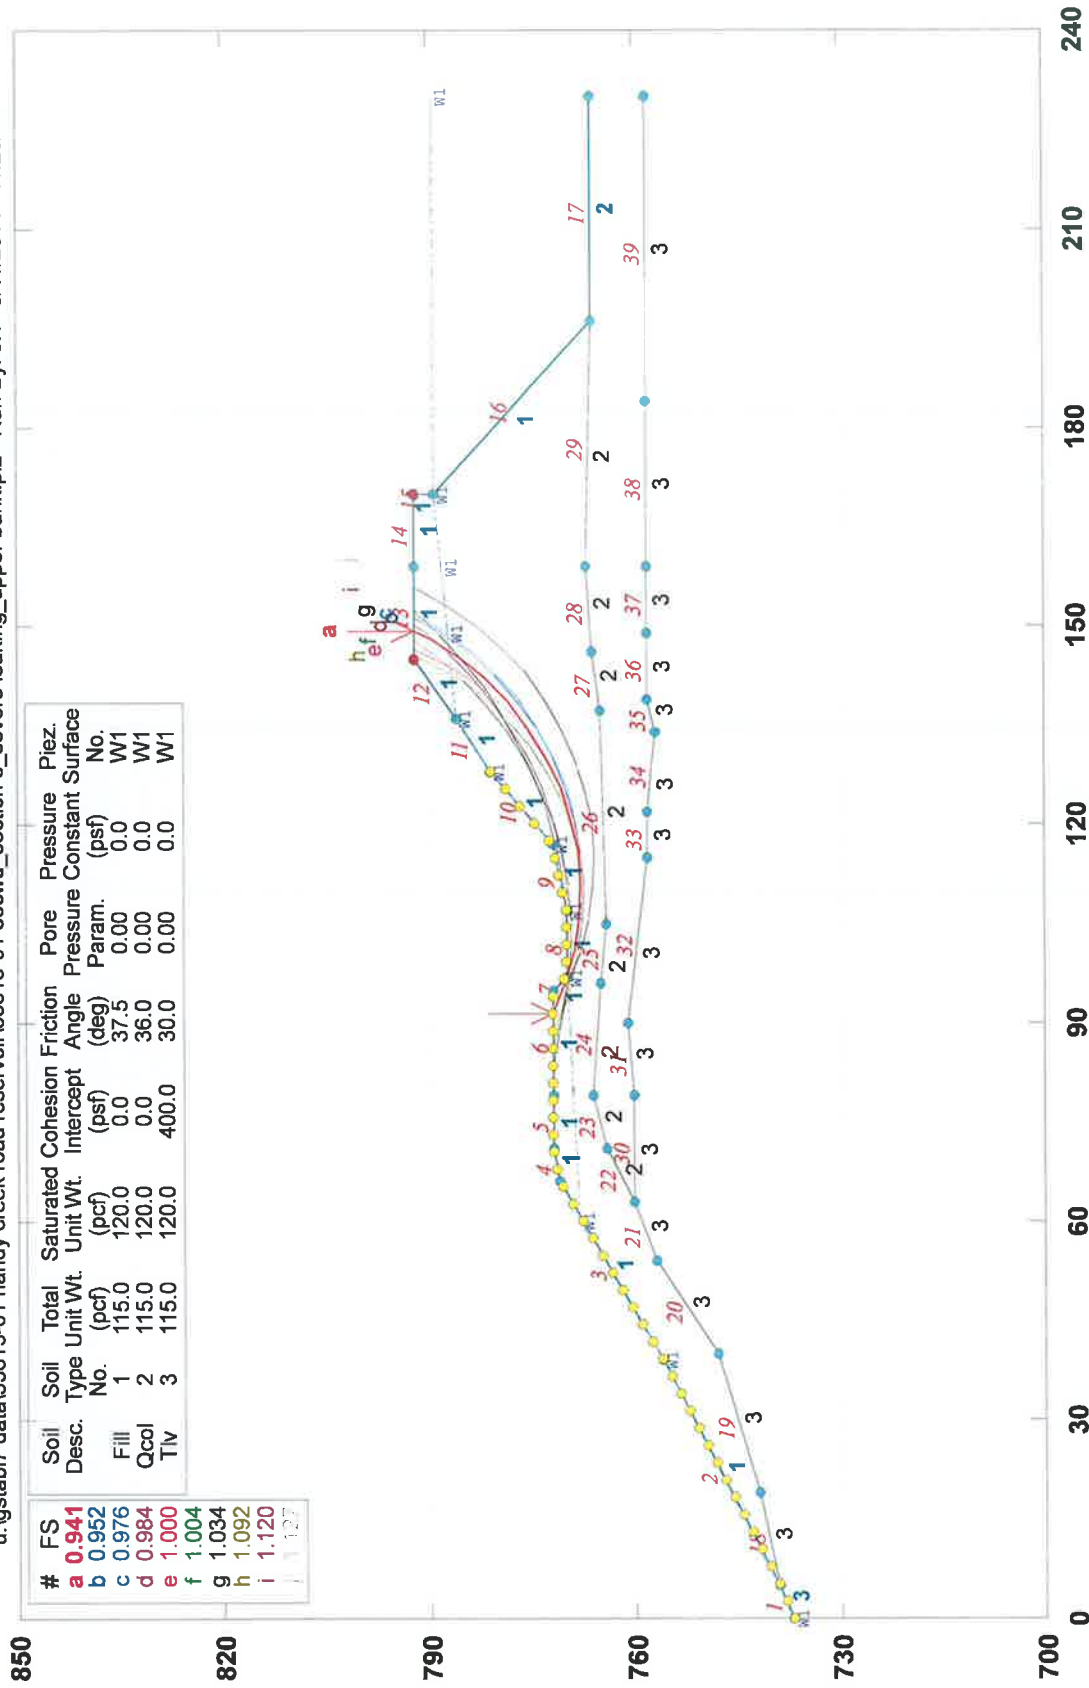
# 33615-01 Handy Creek Rd. Reservoir Section E-E' - Severe Leak\_Upper\_Static

GSTABL7 v.2 FSmin=0.941

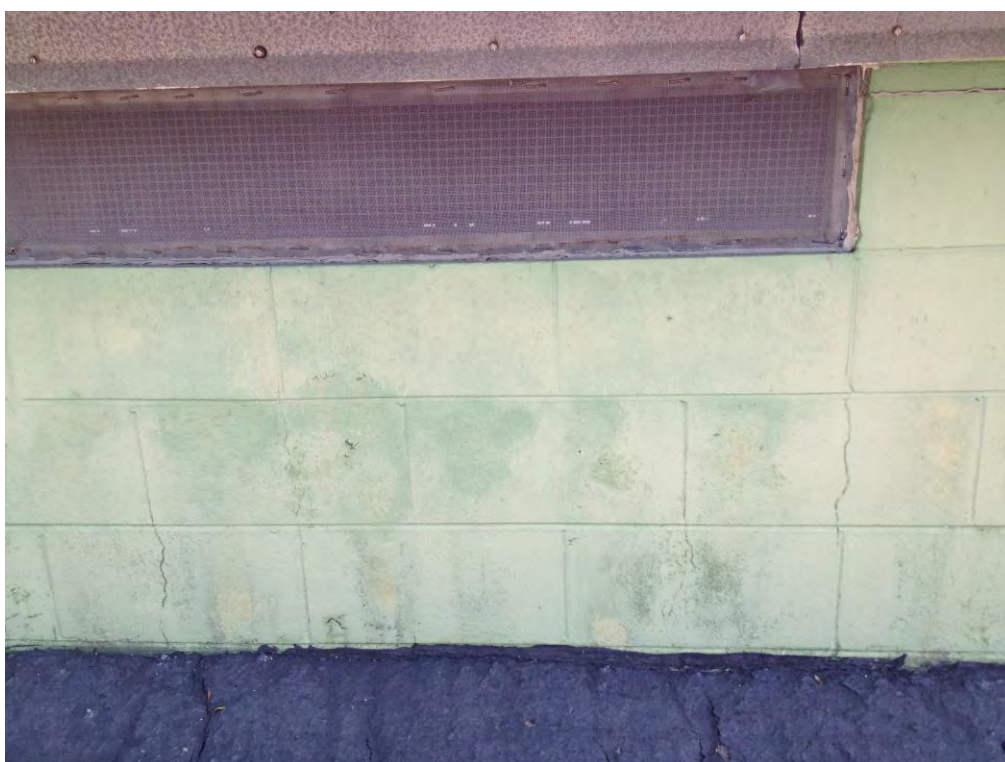
THERMAL SHRINKAGE EFFECTS ON SOUTH WALL 1

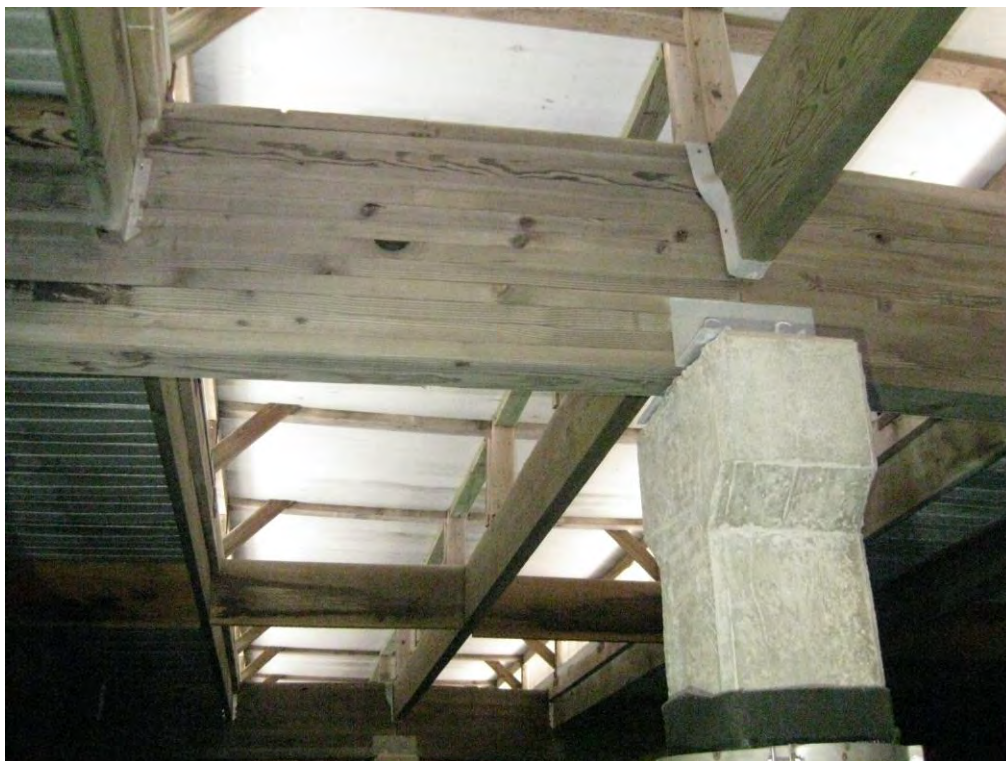
COLUMN WITH LOOSE NUT ( NON-GALVANIZED)

Structural Upkeep: Bolt tightening and replacement of non-conforming hardware will greatly contribute to extending the longevity of the reservoir system.

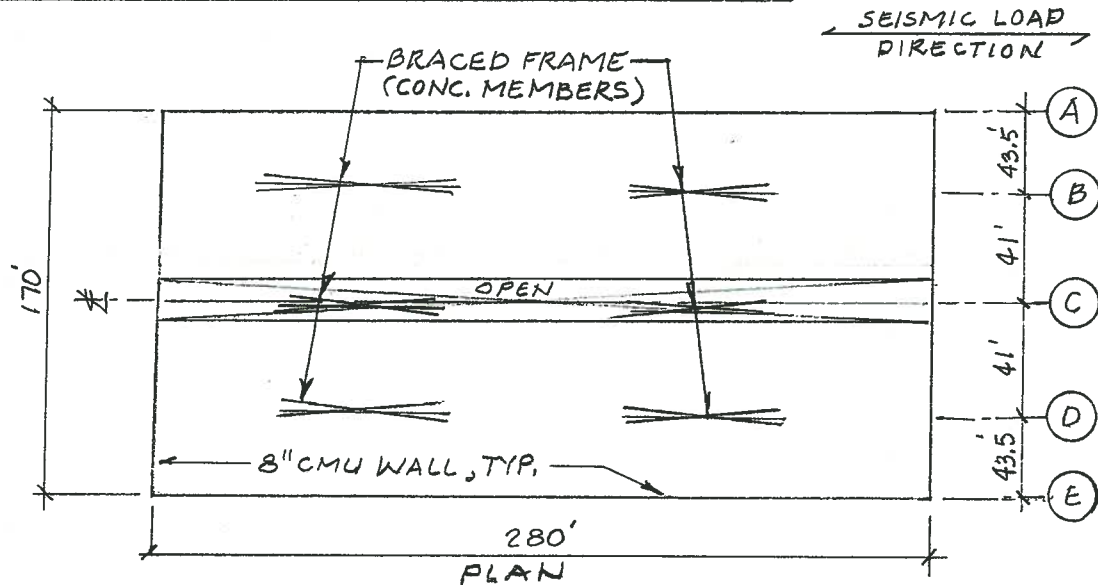
### CHECK LONGITUDINAL LOADING WITH OPEN RIDGE

NOTE: THE FRAMES ALONG GRID C ARE OF NO VALUE SINCE THERE IS NO MEANS TO TRANSFER SEISMIC LOADS TO THEM.

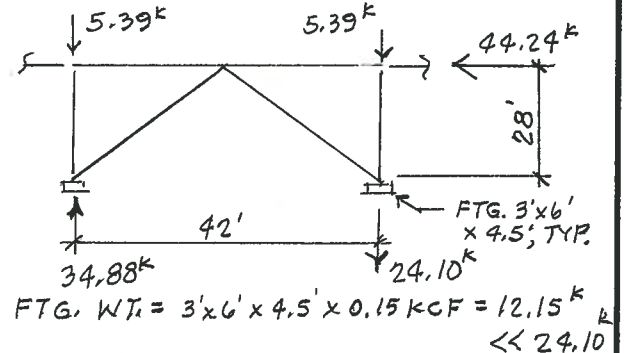
BY INSPECTION, FRAMES WILL OVERTURN
