**EAST ORANGE COUNTY WATER DISTRICT  
PETERS CANYON AND VISTA PANORAMA  
RESERVOIR**

**CONDITION ASSESSMENT**

**FINAL**  
April 2019

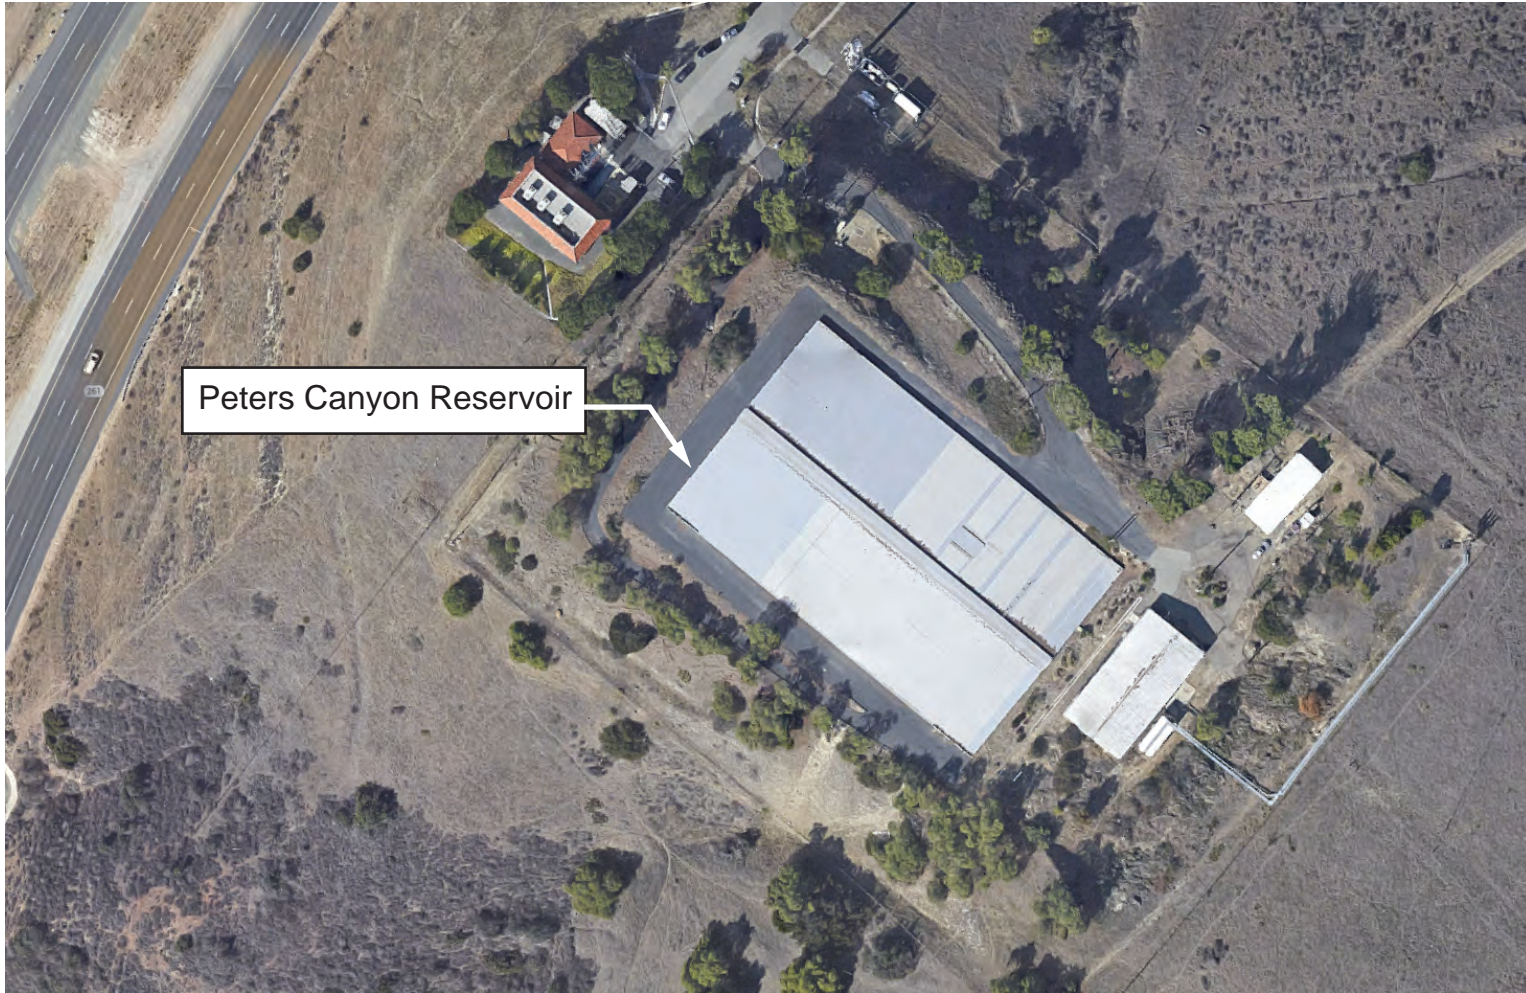
**Figure 1**  
**Aerial View of Peters**  
**Canyon Reservoir**

road which intersects with Jamboree Road. An aerial view of the site is provided on Figure 1.

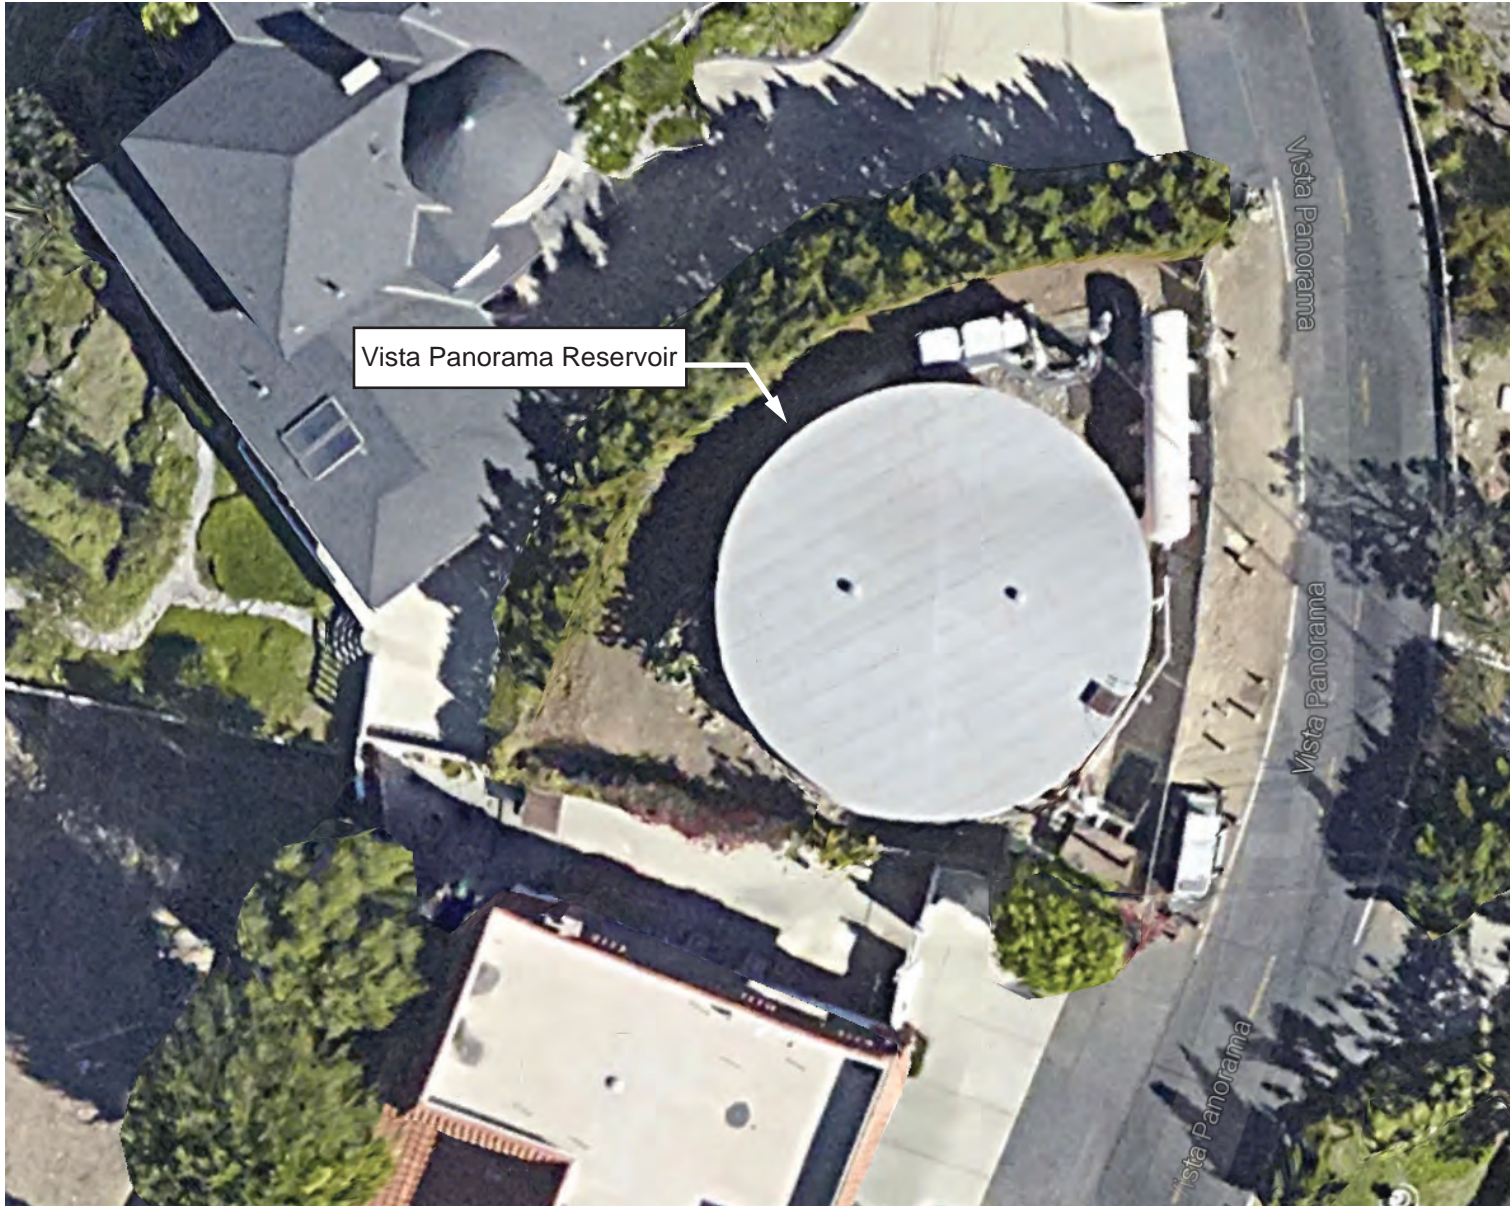
**Figure 2**  
**Aerial View of Vista**  
**Panorama Reservoir**

The Vista Panorama Reservoir is a 46.5-ft diameter circular, conventional (non-prestressed) reinforced concrete tank with a wood-framed roof. The tank was built in the 1930's. The tank is above ground and the wall height is approximately 12 ft. The wood roof beams are supported on a total of 7 interior steel columns. The storage capacity of the tank is approximately 150,000 gallons. An aerial view of the reservoir is provided in Figure 2.

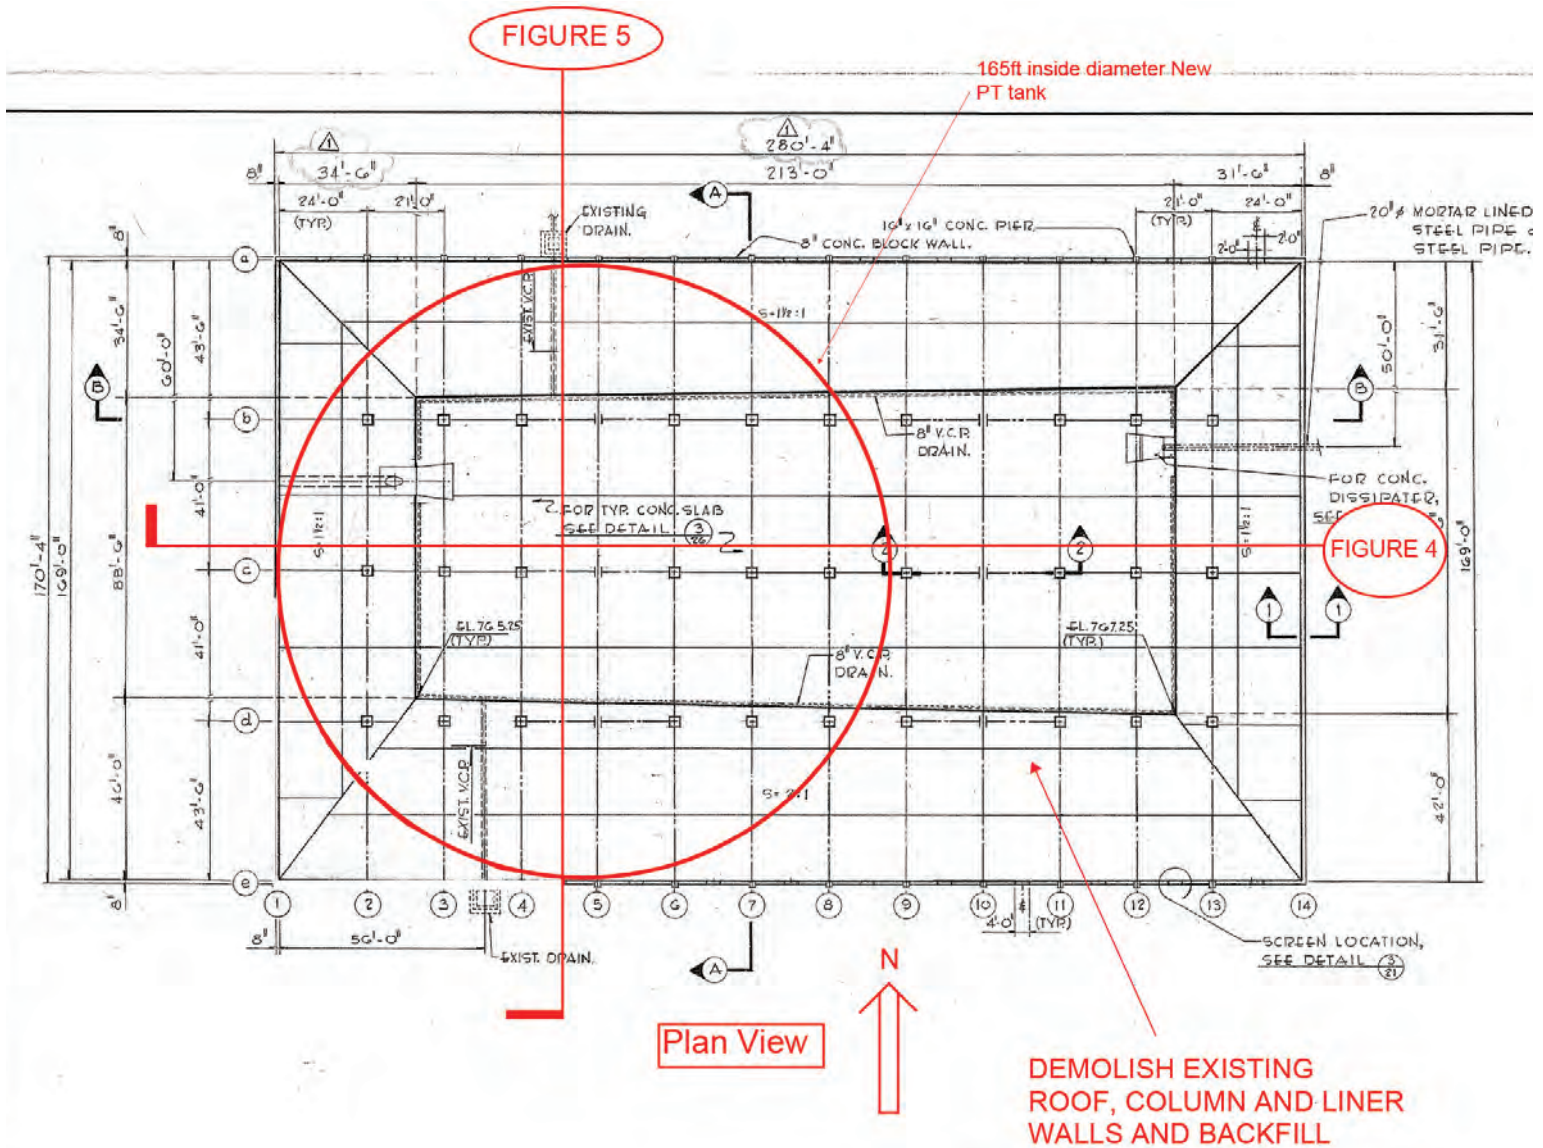
Figure 3  
Peters Canyon Reservoir -  
Layout of New PT tank

Figures 3, 4, and 5 show a conceptual layout and sections of a new prestressed concrete tank describing the construction work anticipated. We used the layout shown in these Figures to estimate the rough construction cost. We located the tank towards the west end of the existing reservoir to provide additional space on the east end, which could be valuable space used for other necessary site developments, such as new or expanded water treatment facilities.

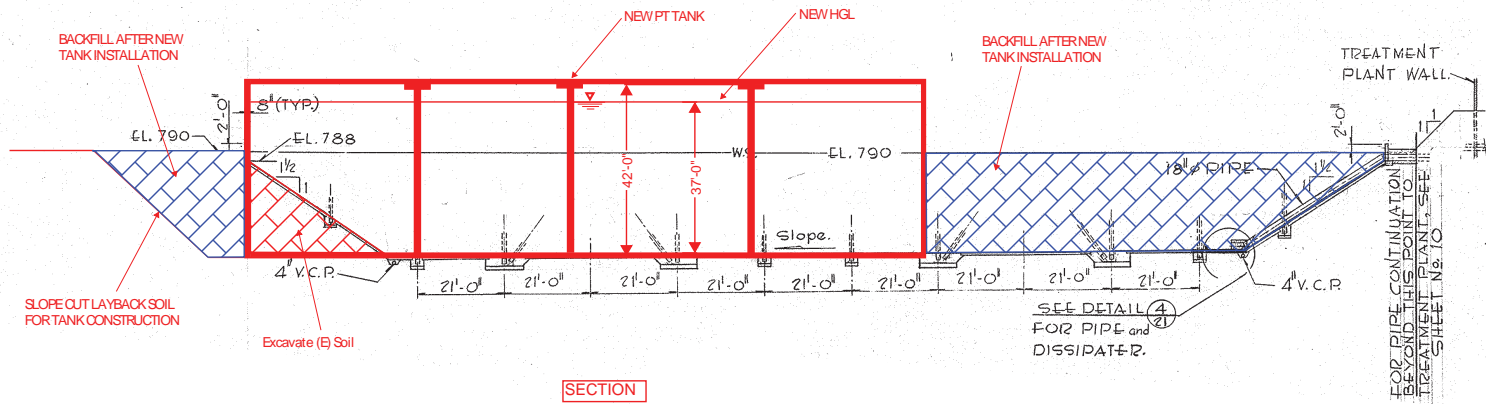
**Figure 4**  
**Peters Canyon Reservoir -**  
**East West Section of**  
**New PT tank**

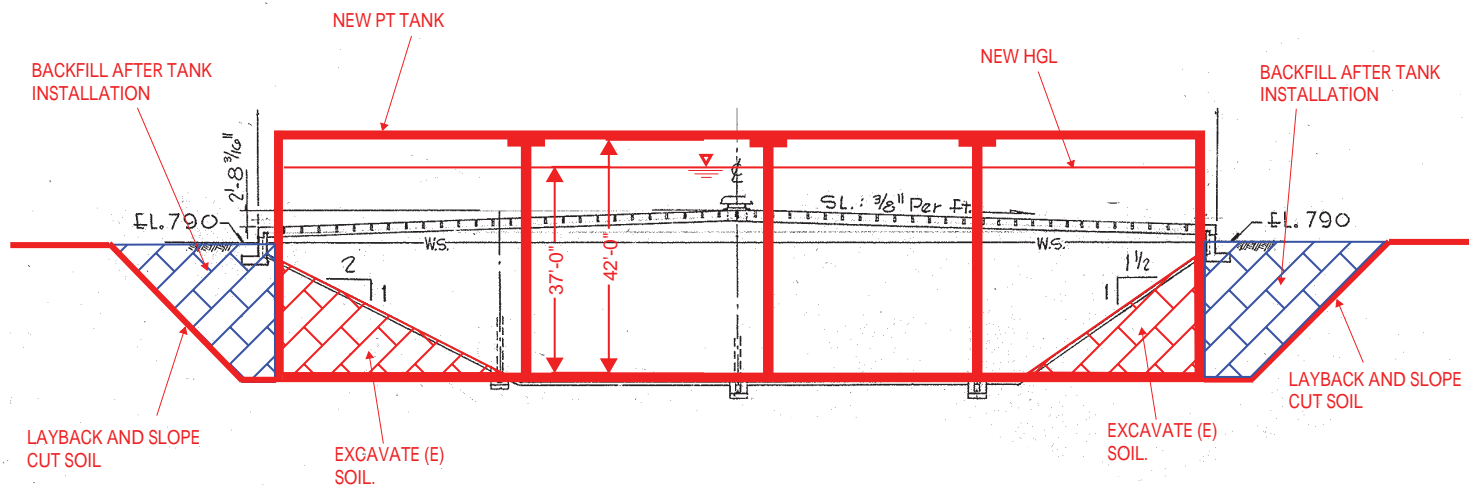
**Figure 5**  
**Peters Canyon Reservoir**  
**-North South Section**  
**of new PT tank**
