Peters Canyon and Vista Panorama Reservoir Condition Assessment

Subject: **GEOTECHNICAL AND SEISMIC HAZARD ASSESSMENT REPORT**
Existing 6-Million Gallon Reservoir
East Orange County Water District
Handy Creek Road
Orange, California

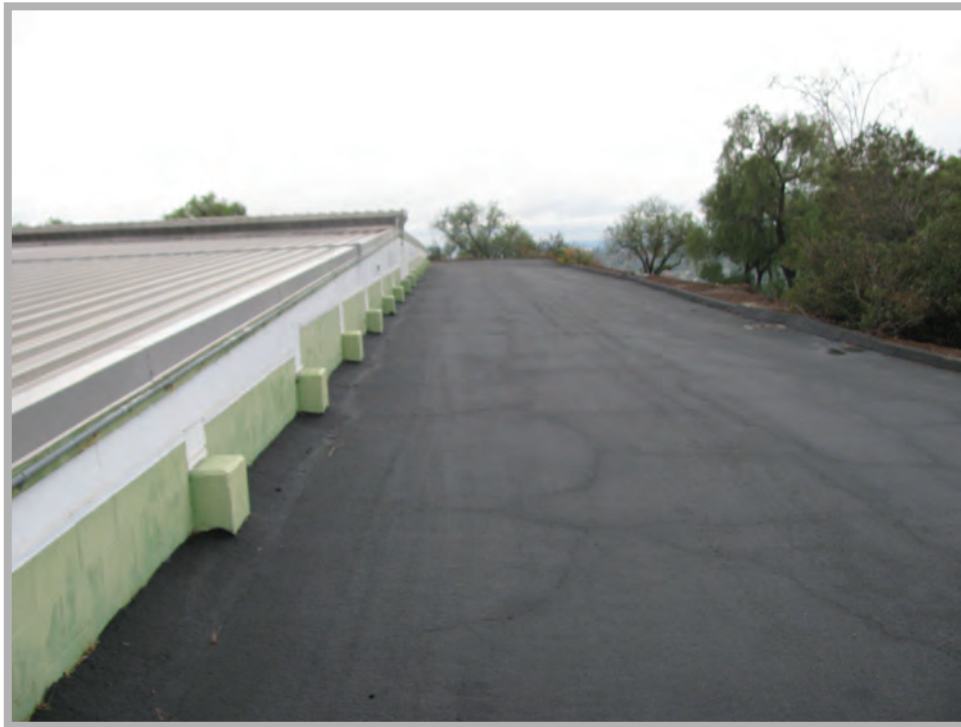
Photo B.6
Peters Canyon Reservoir - Typical Roofing and Flashing

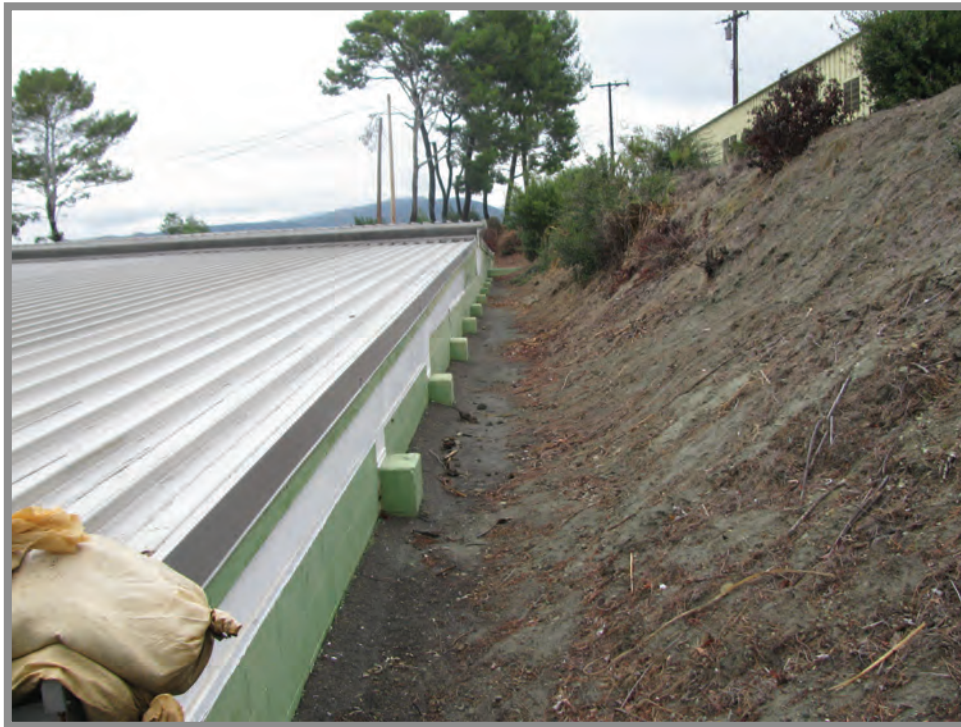
Photo B.16
Peters Canyon Reservoir South Wall Looking North-East

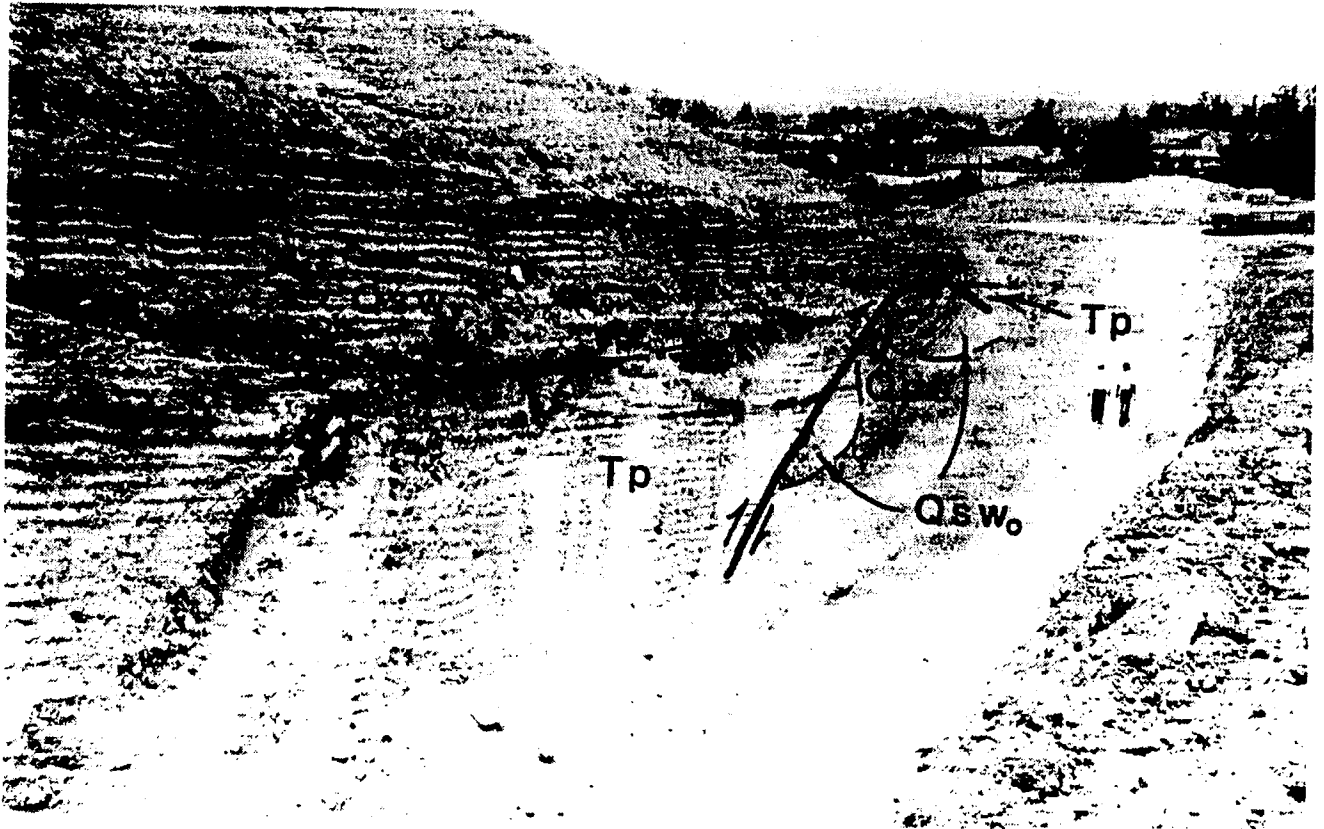
parallel-to-bedding displacement at depth and a marked change to a south-dipping (gravity slide) plane near the surface as a continuous arcing shear surface (Photographs 1 and 2). Measured offset was indicated to be at least 250 feet (75m). Similar faulting conditions have been revealed at other localities. At a second location, (Pleistocene) terrace deposits have been substantially deformed on the downthrown (south) side. The stratification within these Pleistocene river gravels and overlying (Holocene?) colluvial deposits now dips to the south and away from the fault at 40° to 60°. At this same location, the resisting force along a stratum has been overcome by this tilting and (block) failure has resulted in the southerly direction.

Photograph 1. View looking south at east wall of bulldozer trench. Perrita Hills fault at south end. Wall height is about 15 feet (4.6m). Qswy = younger slopewash, Qsw0 = older slopewash, Qps = older paleosol, Tp = Puente Formation.
